# LANDSLIDE REPAIRS ON US-180 BETWEEN MILEPOSTS 13 AND 19, NEAR LUNA, CATRON COUNTY, NEW MEXICO

SUSAN GALLAGHER

Materials Lab, New Mexico State Highway and Transportation Department, P.O. Box 1149, Santa Fe, NM 87504

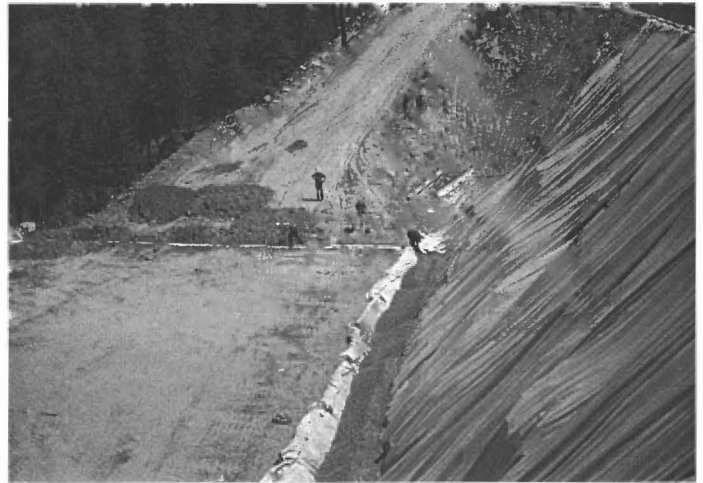
Remediation consisted of removing the mobile slide mass and organic shear plane and keying the new embankment material into bedrock. Approximately 12,000 yd<sup>3</sup> were excavated. A french drain, consisting of gravel wrapped in filter fabric, was placed along the backslope of the excavation in order to divert water away from the new embankment (Fig. 2). A perforated lateral drain collector pipe was placed at the bottom of the french drain and connected to a nonperforated pipe that discharged above the stream at the lowest elevation of excavation. Select fill was placed in 12 in. lifts and compacted to 95% of maximum obtainable density as determined by AASHTO T-99 (Proctor test). Select fill consisted of sandy, well-draining material with a high angle of internal friction (35°) and little or no cohesion. This material was obtained from cut slopes adjacent to the new Luna bridge 6 mi from the excavation. The replacement material was keyed into bedrock for a 20 ft width (see cross-section and profile, Figs. 3, 4). Construction took approximately 7 weeks to complete.

FIGURE 2. Landslide repair at MP 13.5, showing french drain being constructed on back slope of excavation, autumn 1993.

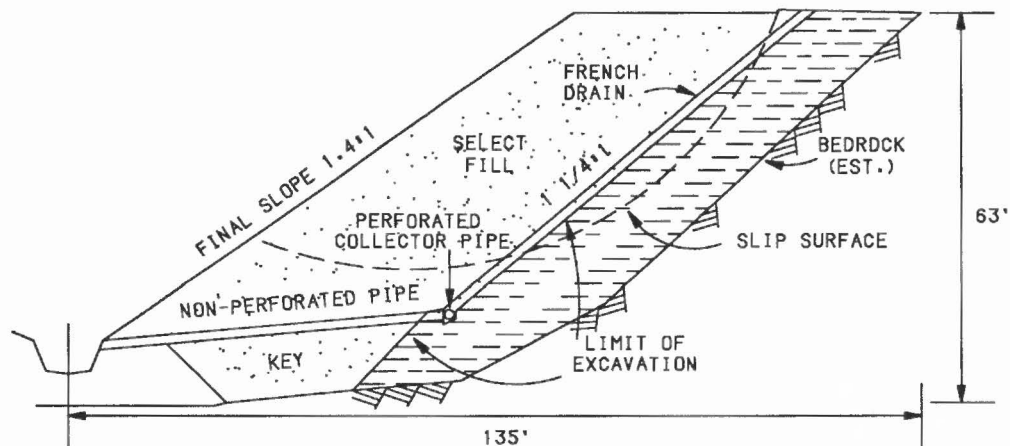
FIGURE 3. Cross-section at MP 13.5, detailing slide repair.

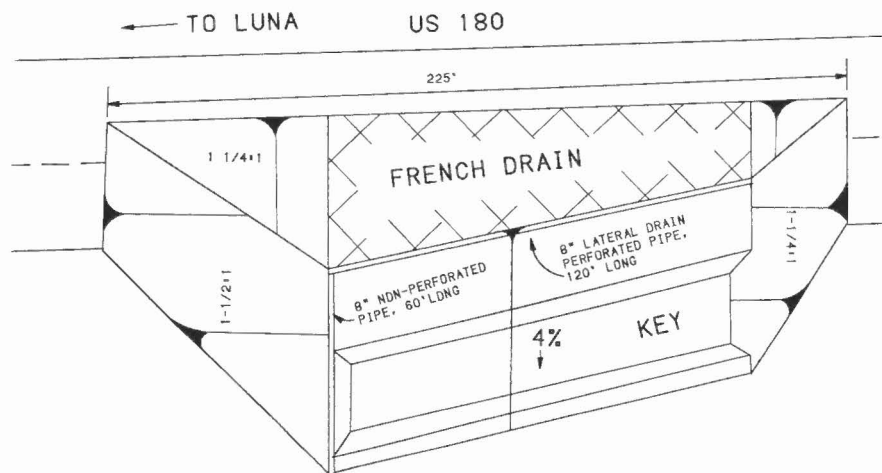
FIGURE 4. Plan view of excavated area at MP 13.5.

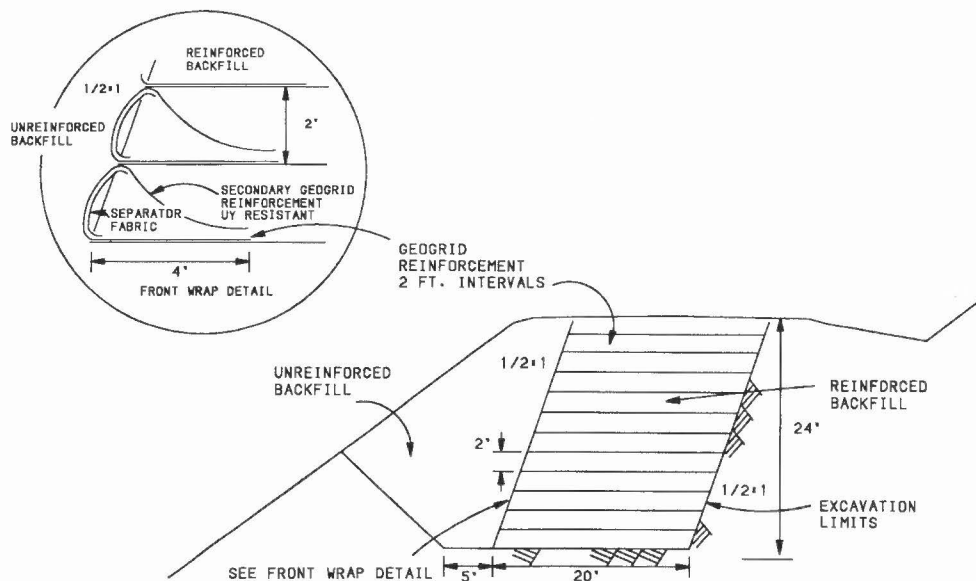
The problem of the slide movement at MP 18.66 was being compounded by a stream undercutting and removing material toward the base of the slide mass. During initial construction of this road, the stream was rechannelled away from the bank. After many years of eroding its way back to its natural channel, it began to cut away at the embankment built to support the road above. As erosion continued, the outlet section of a 48-in. culvert, 30 ft above the stream, lost support. This 8-ft section eventually fell off. The slope was gradually steepened to nearly vertical. MP 18.54 showed the same type of settlement of the pavement and shoulder as MP 18.66, but without loss of the side slope. Both areas had received as many as 14 in. of asphalt patches over the years.

FIGURE 6. Cross-section at MP 18.66, showing geogrid reinforcement in top 24 ft of roadway.

These two areas were repaired using a soil reinforcing geogrid fabric. The first area (MP 18.54) was 250 ft in length and required an excavation of 2400 yd<sup>3</sup>. It was reconstructed beginning at a depth of 12 ft with 10 layers of geogrid spaced 1 ft apart using backfill obtained from the opposite cut slope, after discarding large boulders and clumps of clay. The backfill was again obtained from the opposite cut slope. This area also contained a zone of unreinforced backfill on the outside of the reinforced area (Figs. 5, 6). Once begun, these two repairs took about 10 weeks to complete.
