## The Endee pipeline leak-implications for treating ground-water contamination beneath the Great Plains, eastern New Mexico

William J. Stone

2001, pp. 317-319. https://doi.org/10.56577/FFC-52.317

*Geology of Llano Estacado*, Lucas, Spencer G.; Ulmer-Scholle, Dana; [eds.], New Mexico Geological Society 52 nd Annual Fall Field Conference Guidebook, 340 p. https://doi.org/10.56577/FFC-52

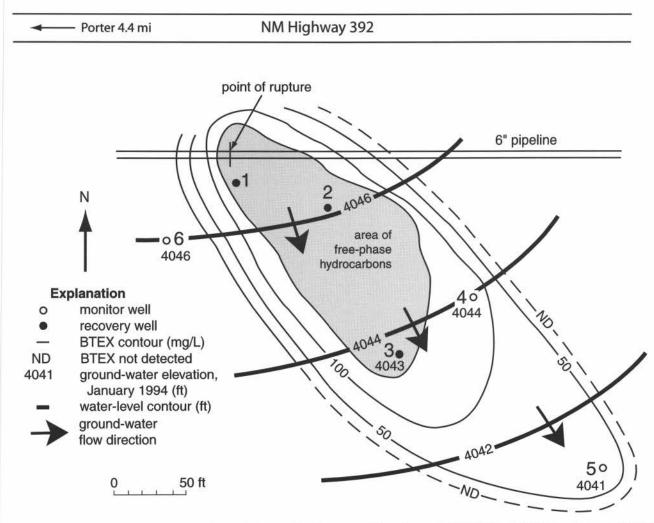
To define the nature and extent of the contamination, six monitoring wells were installed in and around the impacted area (Fig. 1). More specifically, five wells were located within the area of the surface plume (area of discolored soil) and one was located outside of that to the west. These wells revealed that there is a shallow body of saturation (16-36 ft) below ground surface). This water appears to be perched on a well-cemented pebbly zone near the top of the redbeds (Stone, 1999). Water-level measurements suggest flow is southeasterly toward local drainage (Fig. 1).

Characterization of the subsurface plume was made possible by the six monitoring wells. Three of the wells located within the surface plume encountered up to 8 ft of free product floating on the perched water. The other two wells detected major fuel components (benzene, toluene, ethylbenzene and xylene or BTEX) at 11–311 ug/L in the perched ground water, but no free product. The extent of the ground-water plume was found to generally mirror that of the surface plume.

FIGURE 1. The Endee pipeline leak site, Quay County, New Mexico (constructed from figures in NMED files). BTEX contours are from October, 1996 measurements.

Product remediation was undertaken by means of a solar-powered recovery system. This involved outfitting initially two and eventually all three of the wells that penetrated free-phase hydrocarbons with pumps (Fig. 1). The pumps are connected to a storage tank that is emptied periodically. Recovered product is taken to a plant in Tucumcari for oil/water separation and appropriate reclamation. Until March 1994, only free product was collected by the recovery system (Table 1). Thereafter, quantities of water, sometimes exceeding those of product, were also produced. By 1995, more than 5,000 gal of fuel had been removed from the ground. Product-recovery efforts continue today.
