## LANDSLIDES ON "BRAZOS PASS"

WARREN BENNETT

New Mexico Highway Department  
Santa Fe, New Mexico

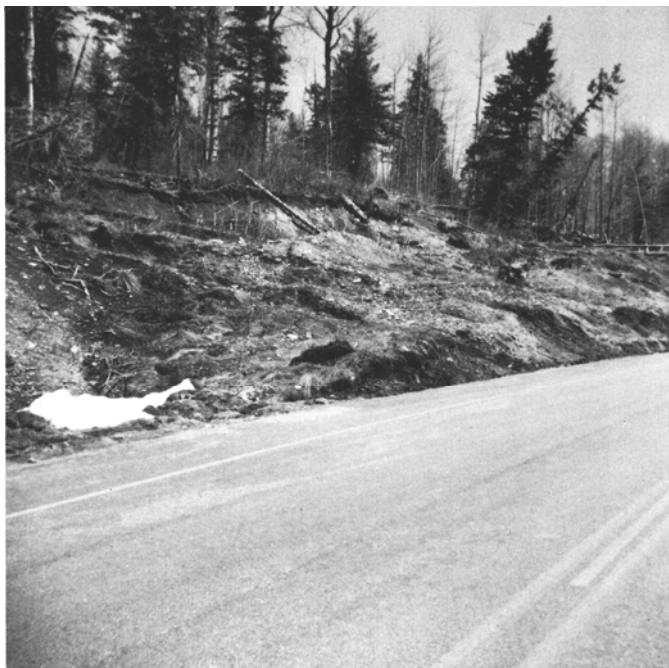
*Figure 1. Cut-slope failure near Station 700+00. Note the leaning trees and the scarp where toe material has been removed from the roadway.*

time. Only a few cuts have remained unaffected and many show massive instability. The failures range from classical rotational shear failures to earth and mud flows. Some mud flows are acting on incredibly flat slopes, commonly 6:1 or flatter.

Because of limited maintenance funds, no corrective measures have been taken to control the failing cut-slopes. Highway maintenance forces will be able to correct a great number of the cut-slope failures utilizing the cosmetic approach described by McGuffey (1973), whereby the slope is cleaned and reshaped and a two foot minimum thickness of open graded materials is placed over the zone of failure. It is not expected that this approach will be effective on some of the larger failures. Rock buttresses and horizontal drains may be required to stabilize the slopes in some areas.

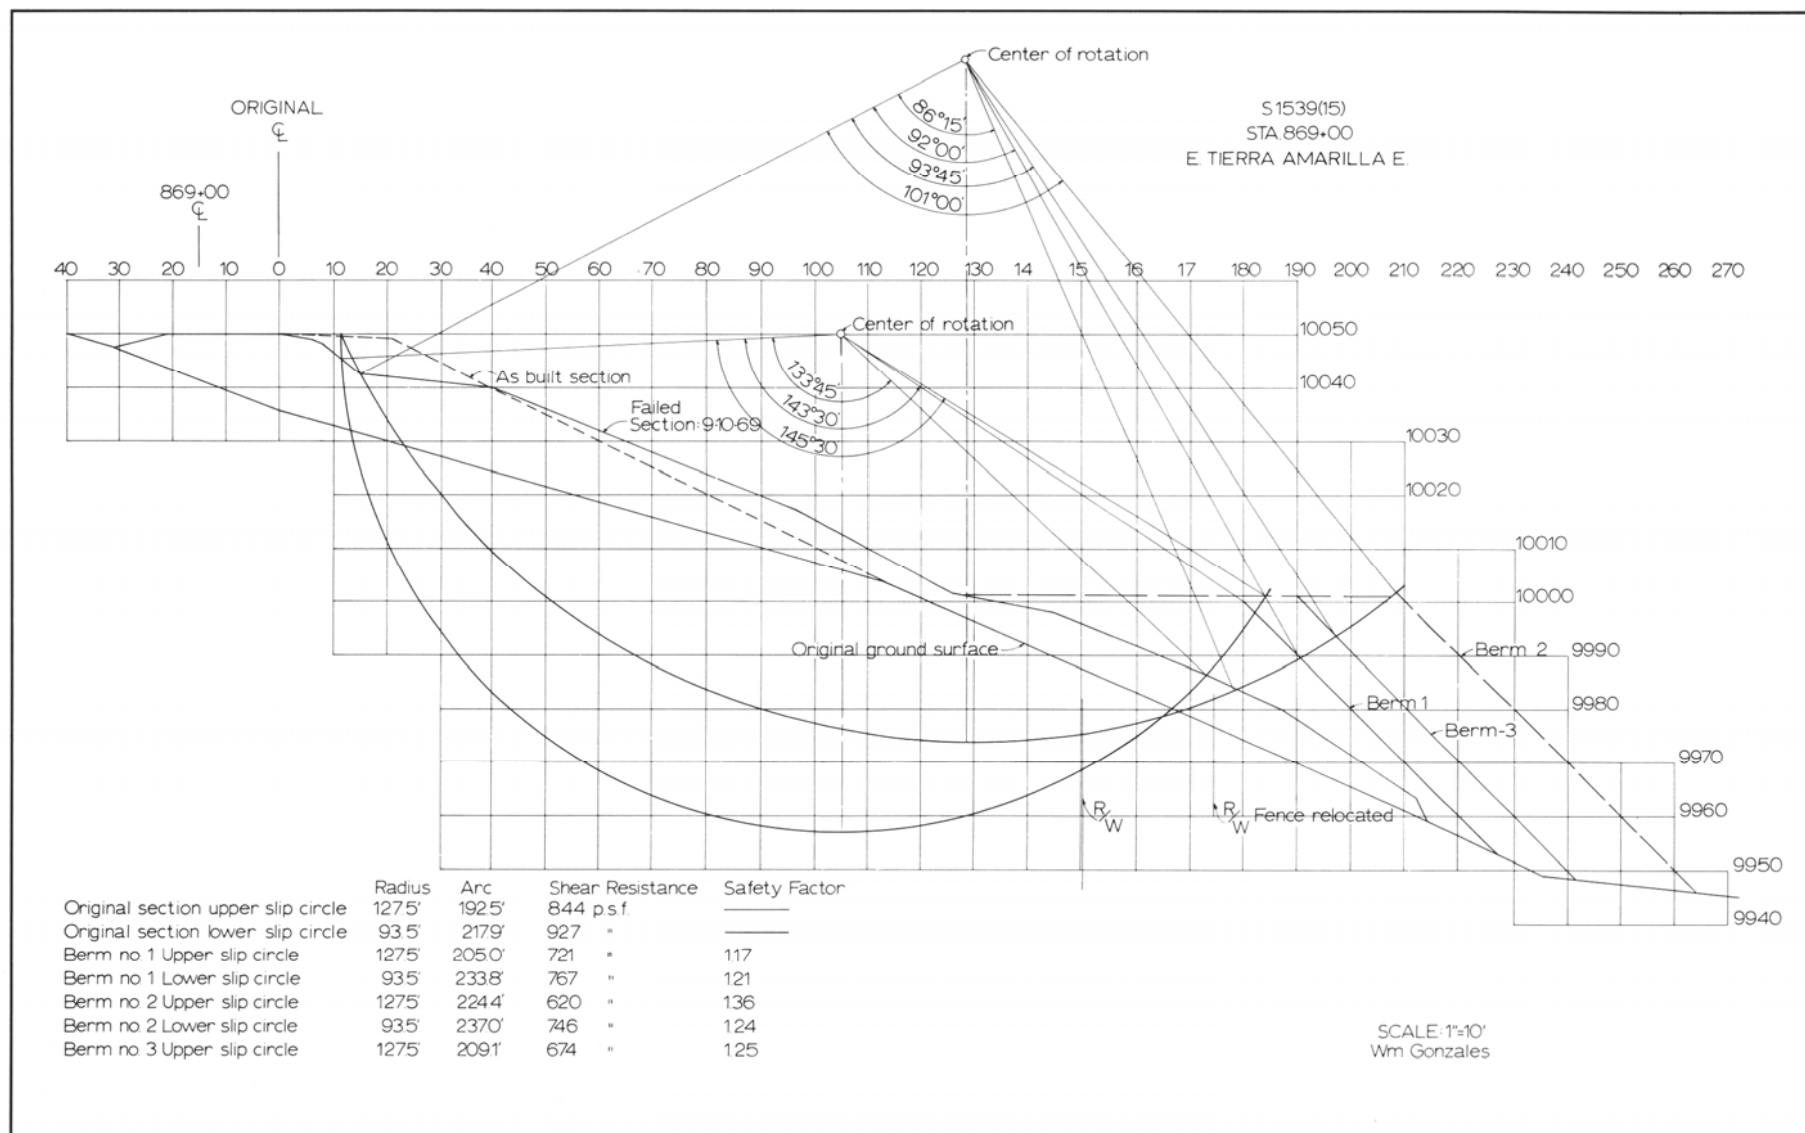
Figure 2. Cross-section at Station 869+00, showing tested configurations.

Using this method, it was found that original highway embankment through the failed areas had factors of safety near 0.64. At station 643+00, the berm selected brought the f.s. to 1.29 using a maximum depth failure arc. At station 840+60, the selected berm gave a f.s. of 1.26 with a shallow slip circle and 1.24 with a full depth arc. At Station 869+00, the berm selected gave factors of safety of 1.25 and 1.24 for maximum depth and shallow seated slides respectively.

located in each slide. It was decided that the best solution for correcting these slides would be to construct a supportive berm along the flanks of the fill which would restrain the driving forces moving through the maximum anticipated failure arc of each slide. A variety of trial berms were examined to determine the necessary berm size. The center of rotation of the maximum failure was estimated to be at the intersection of a horizontal line projected from the crown of the slide and the perpendicular bisector of an arc passing through the crown and foot of the slide. The center of rotation for a more shallow seated failure was placed somewhat higher (Fig. 2). Moments were taken about each center of rotation. The berm size needed to increase the factor of safety of each slide 25 to 50 percent was calculated utilizing Baker and Yoder's equation (1958),  $S = (W_1 D_1 - W_2 D_2) / r l$ , where the driving forces are designated  $W_1$  times their lever arm  $D_1$ , and the resisting forces are designated  $W_2$  times their lever arm  $D_2$ . The radius of the slip surface is  $r$  and the included length of the arc is  $l$ . For purposes of calculation, the slides, having slumped to a point of relative stability, were assumed to have a factor of safety (f.s.) of 1.0. The f.s. for the condition was defined as the ratio of the failed condition to that of the improved condition.

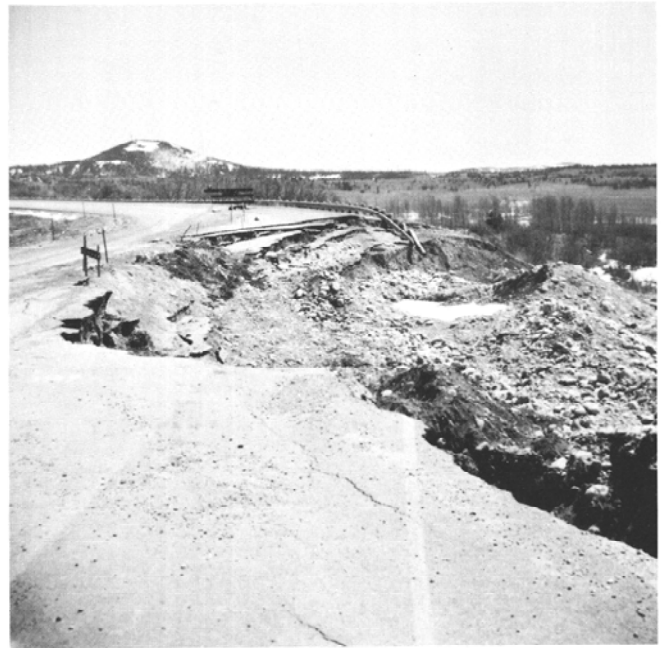
Subsurface exploration of the slide at Station 589+50 revealed that an aquifer in glacial gravel within the old landslide debris had been dammed up by the roadway fill. Hydrostatic pressures had resulted in saturation of the fill, and movement developed along the original ground surface. Test holes established the limits of the aquifer and showed that the till layer beneath the moisture was a gravelly clay, impermeable and competent. A method of correction was selected which involved removal of the slumped material, placement of a granular drainage blanket of open-graded aggregate and replacement of the fill. A 5 x 7 foot reinforced concrete box culvert, which was torn into four pieces by the slide, was also scheduled for replacement.

Figure 3. Fill-slope failure at Station 589+50. The hole at the right foreground was caused by erosion through a gap in the severed box culvert.

tion 589+50, strength parameters typical of the granular material,  $\phi = 30^\circ$  and  $c = 0$ , were used, since the entire area was to be underlain by granular material. These figures were then inserted into the standard equation for translatory slides to determine the factor of safety. The equation is  $f.s. = (\sum N \tan \phi + c l) / \sum D$  where  $\sum N$  is the sum of the tangential forces,  $\sum D$  is the sum of the driving forces,  $\phi$  is the angle of

internal friction,  $c$  is the cohesion and  $l$  is the length of the sliding plane. Computation yielded a factor of safety of 2.8 without the addition of a berm or other stabilizing device. Such f.s. is obviously adequate; however, to guard against plugging of the gravel blanket and subsequent problems, a perforated pipe drain was designed to be placed in the lower part of the aquifer below the uphill borrow ditch. The pipe will divert most of the water before it passes into the drainage blanket and serve to lower the hydrostatic head.

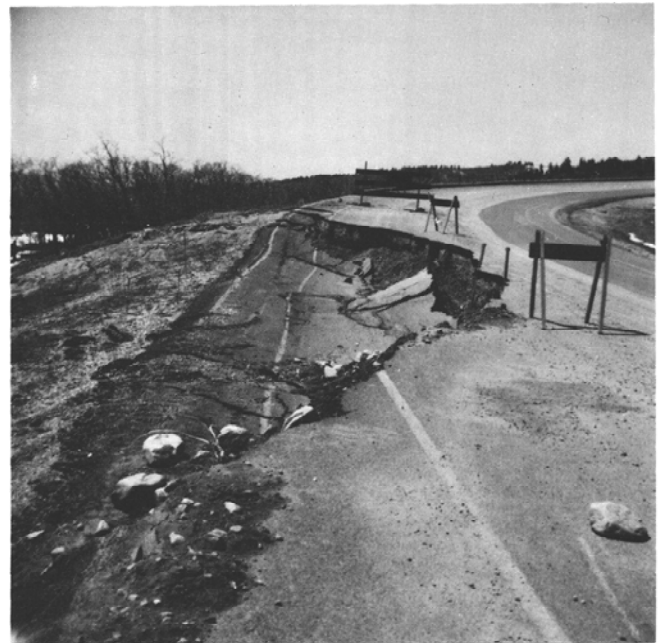
Early in 1973, movement was noted at two places within the roadway fill. One of these areas, at Station 589+50 (Fig. 3), had not shown distress previously. The other area, Station 643+00 (Fig. 4), showed renewed movement at and on either side of the previous slide.

Figure 4. Upper section of the fill-slope failure near Station 643+00. Another failure lies immediately behind the photographer.

Subsurface inspection in the area around Station 643+00 indicated that the previously installed perforated pipe was working well; no water seepage was found downstream from the pipe. Probing within the roadway prism, above the landslide and below the perforated pipe, showed a number of erratic, small aquifers about 30 to 40 feet below the grade, apparently developed in fractures in the disturbed shale. The depth to the water precluded the use of perforated pipe for drainage and, horizontal drains were judged unreliable because of the improbability of intercepting the water within the generally unfractured shale. The movement of the slide, formerly rotational, had been modified by the berm into translatory displacement, based somewhat below the natural ground surface. The two problems, lack of drainage and translatory movement, suggested the solution used for the slide at Station 589+50, and a granular drainage blanket, set on a stable series of benches below the slide plane, would give a f.s. of 1.74 with the original corrective berm replaced and 1.54 if the berm was not rebuilt. As a compromise, in order to provide additional stability and to utilize waste generated by the repair operation, a correction was designed with a 2:1 slope, rather than the initial 1 1/2:1 slope. With a f.s. of 1.61, this design was accepted (Fig. 5).

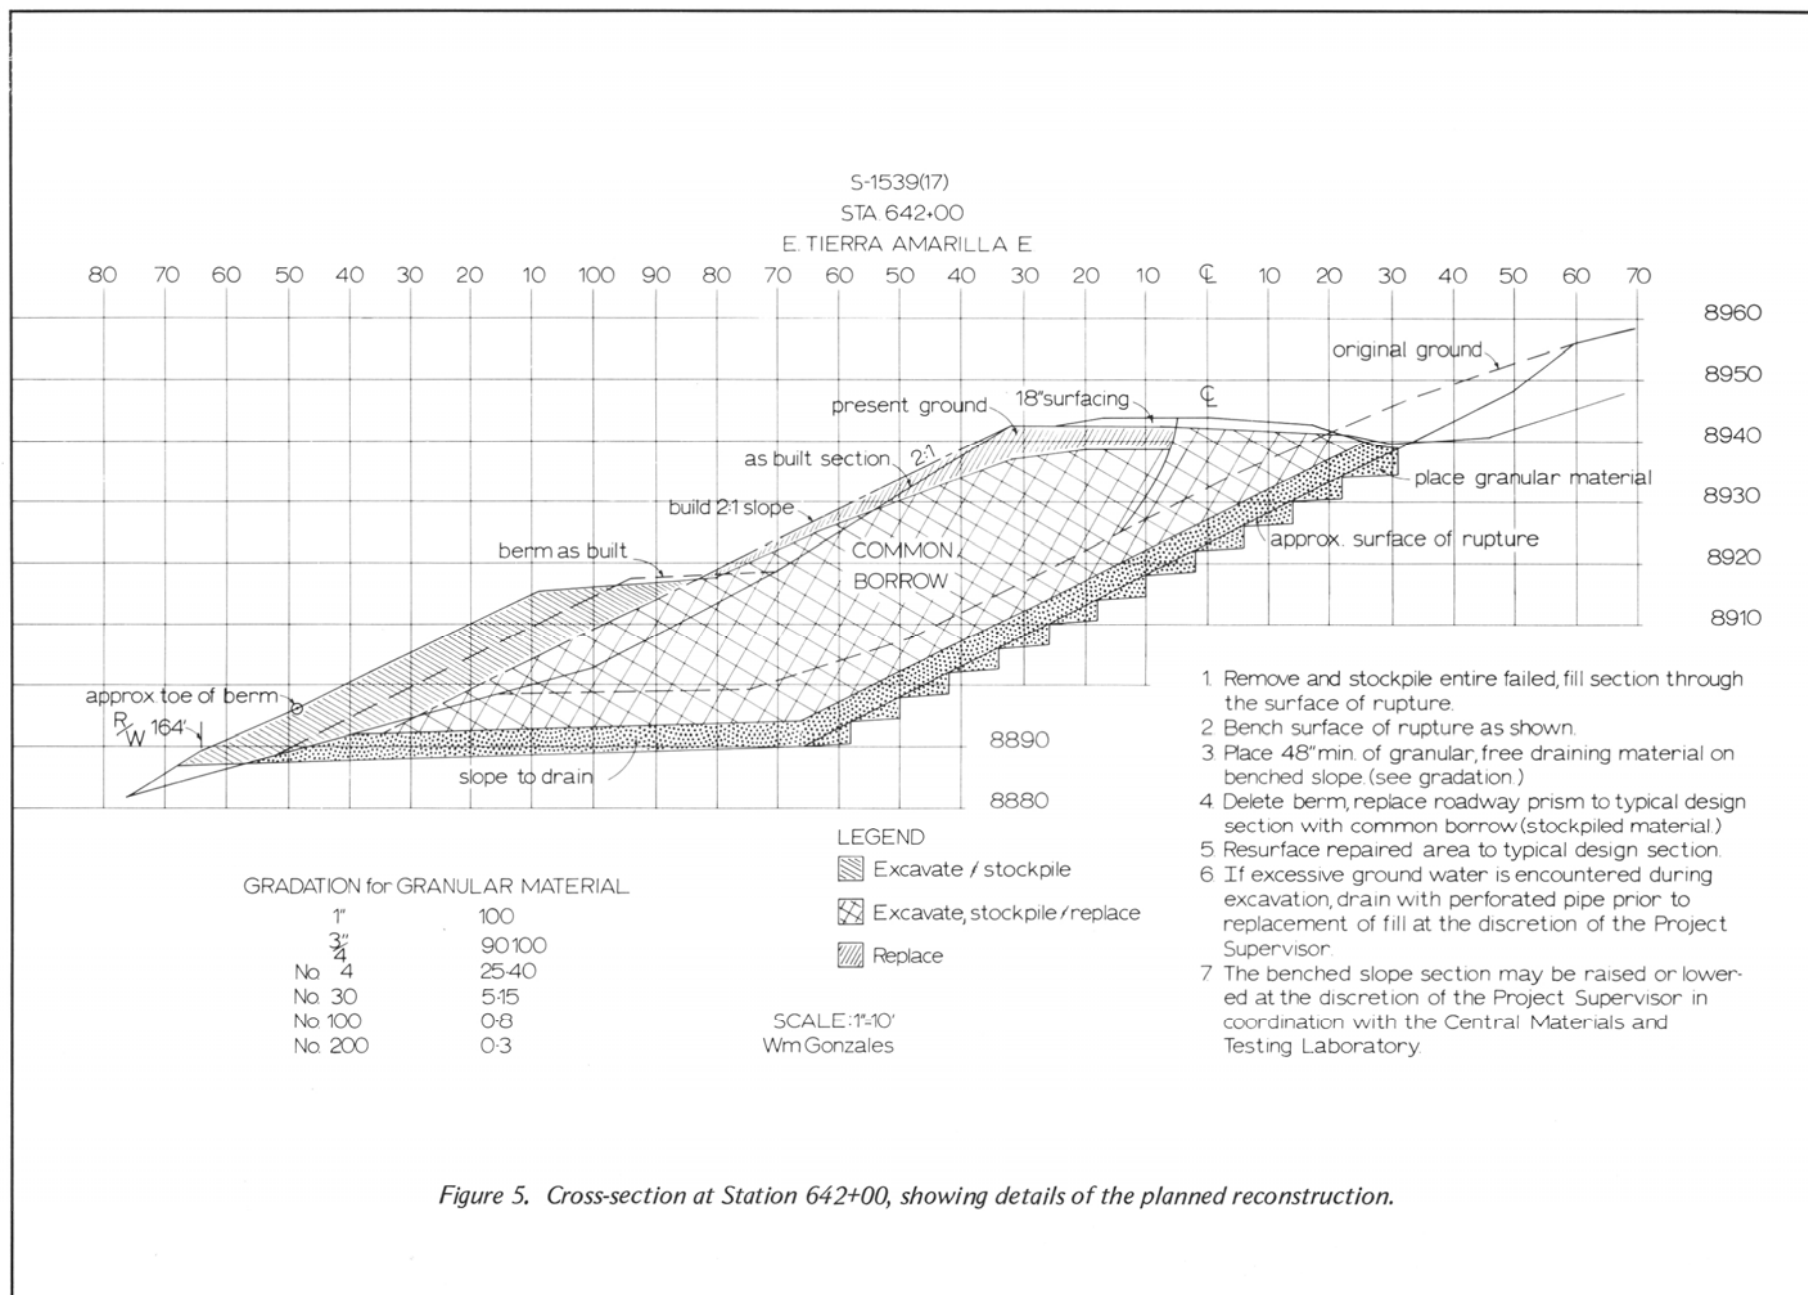
Figure 5. Cross-section at Station 642+00, showing details of the planned reconstruction.

On both slides, the drainage blanket will have a maximum thickness of 48 inches to allow for some plugging by the overlying fill during and after construction. The gradation specifications will require 100 percent smaller than 1 inch, 90 to 100 percent passing the 3/4 inch sieve, 25 to 40 percent below the number 4 sieve and less than 8 percent and 3 percent passing the number 100 and number 200 sieves, respectively. Gravel was obtained from a pit in reworked glacial gravels in terraces
