## *Stabilization of a reactivated landslide near Wagon Mound on Interstate 25*

# STABILIZATION OF A REACTIVATED LANDSLIDE NEAR WAGON MOUND ON INTERSTATE 25

ARLON D. LOVELACE  
New Mexico State Highway Department  
Santa Fe, New Mexico, 87503

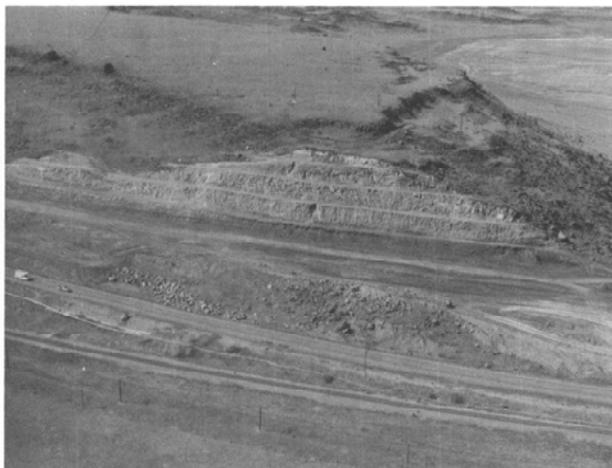
The initial slide movement was about 1.5 in. every 24 hours. The main surface of rupture and movement was along a 6 to 12 in. bed of saturated montmorillonitic clay about 20 ft above grade. The crown of the slide was marked by a continuous arcuate crack, as much as 2 ft wide, near the periphery

Figure 1. Failed slope, February, 1970, looking west.

The analysis of this failure showed the slide to be a slip circle or a rotational type failure. The rupture surface was a circular arc intersecting the large crack at the crown of the slide and the montmorillonite bed at the face of the cut. The center of rotation was located at the intersection of the perpendicular bisector of the arc and a line drawn perpendicular to the failure slope at the head of the slide. The average shearing resistance along the failed surface was computed and several trial solutions were devised using slope flattening and head removal.

The redesign recommendation called for a 1.5:1 cut slope above the lower bench, a 65 ft bench about 80 ft above ditch line elevation and a 1:1 slope above the 65 ft bench. This required an additional 93,000 yd<sup>3</sup> of loose rock excavation which was to be utilized for plating the old lake bed a short distance north. It was recommended that another antithetic slide, which was resting against the north end of this slide mass, be decapitated in order to avoid failure in the upper cut slope. This required an additional 22,000 yd<sup>3</sup> of rock excavation, also to be utilized as fill for the lake bed. Upon completion of excavation any large cracks remaining were to be sealed with clay soil in the upper part of the cut. This soil was to be compacted and bladed to drain.

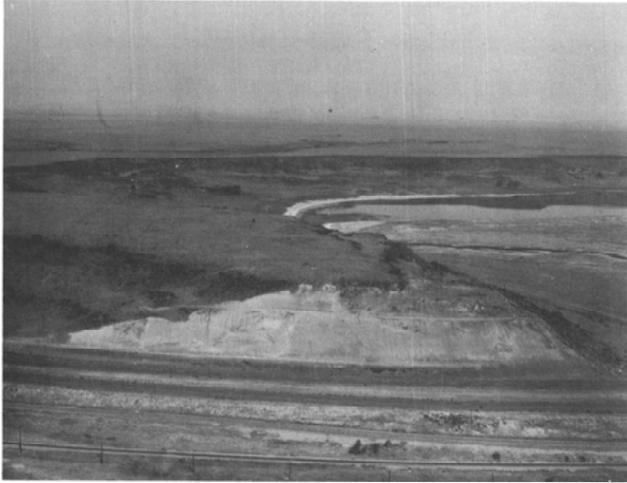
Additional subsurface investigation during January, 1973, indicated that a free draining condition still existed along the failure surface. The larger of the two antithetic slides had slumped about 10 ft at the crown in the 45 ft bench and its toe had progressed several feet across the lower bench. A test hole at the back of the 45 ft bench did not indicate that ground water was flowing through the granular materials below the basalt into the failure surface; however, a test hole above a seepage zone just above the lower bench indicated that a considerable amount of rain and snow melt was slowly percolating through the entire slide mass to the failure surface. Water apparently enters the many cracks and fissures during periods of precipitation, makes its way to the failure surface, relubricates the surface and causes additional movement. Therefore, some hydrostatic pressure exists part of the time.

The entire slide mass is very complex, consisting of a rather large slide moving in an east-southeasterly direction, and smaller auxiliary slides on the flanks of the larger block. All of the slides have one common fault at their crown but movement in the smaller slides is oblique to the main mass. Other

*Figure 4. Aerial view looking west of additional distress January 16, 1973. Note auxiliary slides near the north and south end of cut slope.*

The present condition of the slides corroborates the original analysis based primarily on exposed site conditions. Additional movement has obviously been caused by poor drainage on the 1.85:1 slope as well as the upper 45 ft bench. The top of the bench could have provided better drainage if it had been properly shaped and the soils compacted.

Three methods to further stabilize this slope were considered, two for further rebalancing the mechanical forces and the other for chemical treatment. Of the two mechanical methods, one involving further decapitation of the slide and buttressing of the middle slope, was abandoned because it was too expensive, might overload the incompetent shales below the lower bench and would reduce the width of the upper bench excessively. The other mechanical method lowers the upper bench without reducing its width and requires removal and partial replacement of the auxiliary slide. Chemical treatment is probably the most practical but is not the simplest method. It is a relatively new process, which requires the injection of selected chemicals into cracks, fissures and drill holes in the slide to change the type of clays along slip surfaces to more cohesive soils.

It was suggested that several thousand gallons of a thin lime slurry be pumped into the large cracks in the upper bench for experimental purposes. Bench treatment to seal out the water was also recommended. No significant corrective measures have been taken to date. The slide mass does not present an immediate hazard to the traveling public. No catastrophic movement is expected, but the slope is an aesthetic eyesore and may, if further lateral spreading of the failed area occurs, eventually entail a considerable maintenance expense.
