LANDSLIDE REPAIRS ON US-180 BETWEEN MILEPOSTS 13 AND 19, NEAR LUNA, CATRON COUNTY, NEW MEXICO

SUSAN GALLAGHER

Materials Lab, New Mexico State Highway and Transportation Department, P.O. Box 1149, Santa Fe, NM 87504

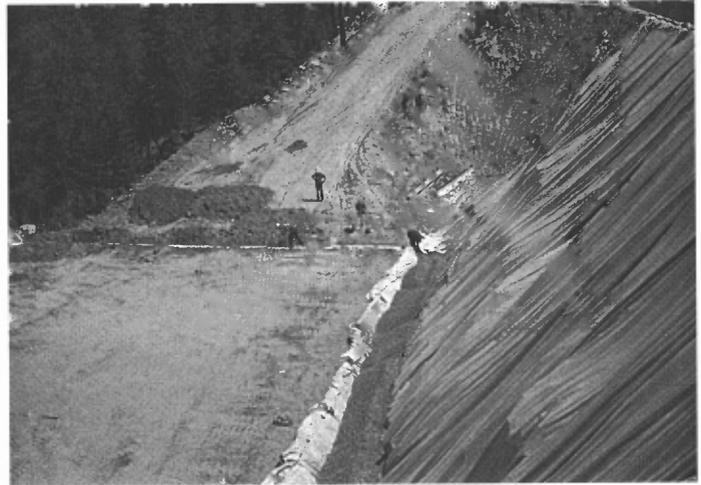
During construction the slide mass began to move again. In early February 1992, the head of the slide dropped 10 in. in a 4-hr period. The ground was wet from recent rain and snow. A series of arcuate cracks and distresses had developed in the roadway over approximately a 200-ft length. The cracks extended from the shoulder of the east bound lane, across the centerline, and 8 ft into the west bound lane. A sag of up to 0.625 ft was measured along the centerline profile for a distance of 150 ft. The contractor cut a shoe fly detour into the adjacent hillside to accommodate traffic. By May 1992, the head of the slide had dropped a total of 4 ft. A typical landslide hummock had also

FIGURE 2. Landslide repair at MP 13.5, showing french drain being constructed on back slope of excavation, autumn 1993.

Remediation consisted of removing the mobile slide mass and organic shear plane and keying the new embankment material into bedrock. Approximately 12,000 yd³ were excavated. A french drain, consisting of gravel wrapped in filter fabric, was placed along the backslope of the excavation in order to divert water away from the new embankment (Fig. 2). A perforated lateral drain collector pipe was placed at the bottom of the french drain and connected to a nonperforated pipe that discharged above the stream at the lowest elevation of excavation. Select fill was placed in 12 in. lifts and compacted to 95% of maximum obtainable density as determined by AASHTO T-99 (Proctor test). Select fill consisted of sandy, well-draining material with a high angle of internal friction (35°) and little or no cohesion. This material was obtained from cut slopes adjacent to the new Luna bridge 6 mi from the excavation. The replacement material was keyed into bedrock for a 20 ft width (see cross-section and profile, Figs. 3, 4). Construction took approximately 7 weeks to complete.

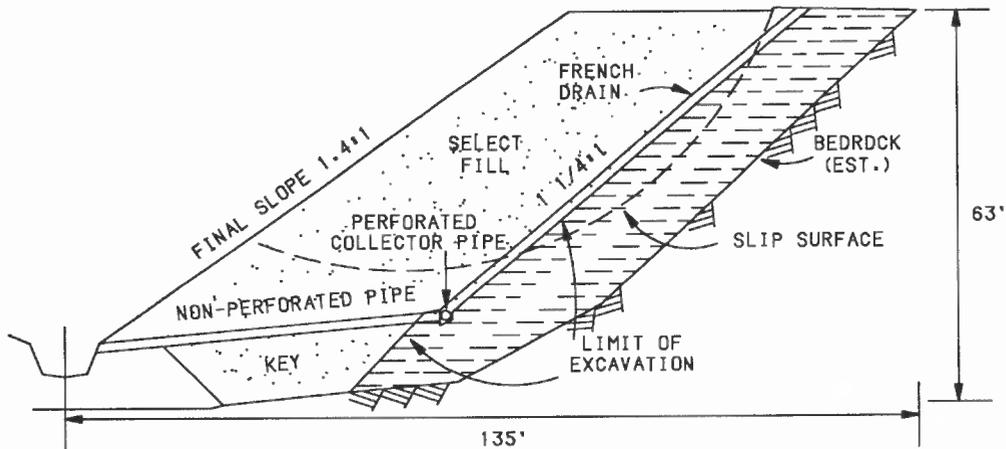
The investigation indicated that the original ground surface had not been cleared and grubbed of its original vegetation and organic debris prior to placement of fill for the highway. The vegetation at the interface of the natural ground and overlying fill eventually decomposed to form a zone of weakness, which formed a shear surface when the overlying fill became saturated by infiltration of snowmelt and rain. The slip surface was located by the inclinometer readings, which showed movement at a 25-ft depth in inclinometer Number 1 and at a 20-ft depth in inclinometer Number 2. The investigation also revealed that the original natural ground was part of a dormant prehistoric landslide mass underlain by a fine- to medium-grained sandstone bedrock.

FIGURE 3. Cross-section at MP 13.5, detailing slide repair.

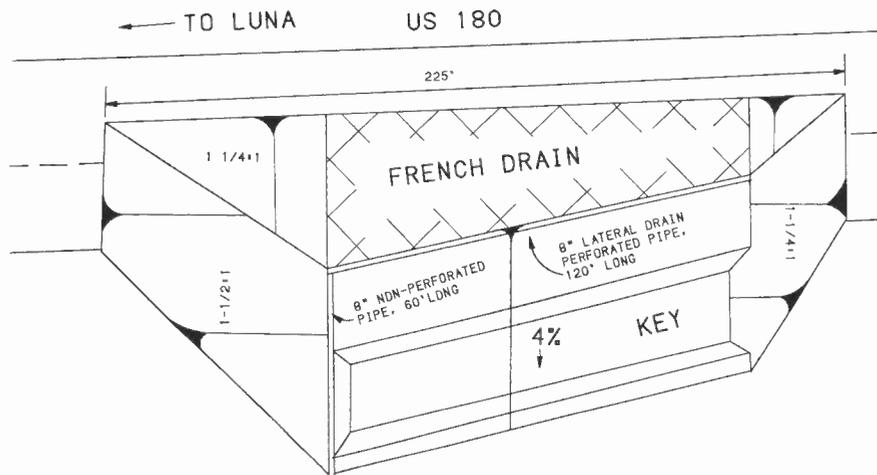
FIGURE 4. Plan view of excavated area at MP 13.5.

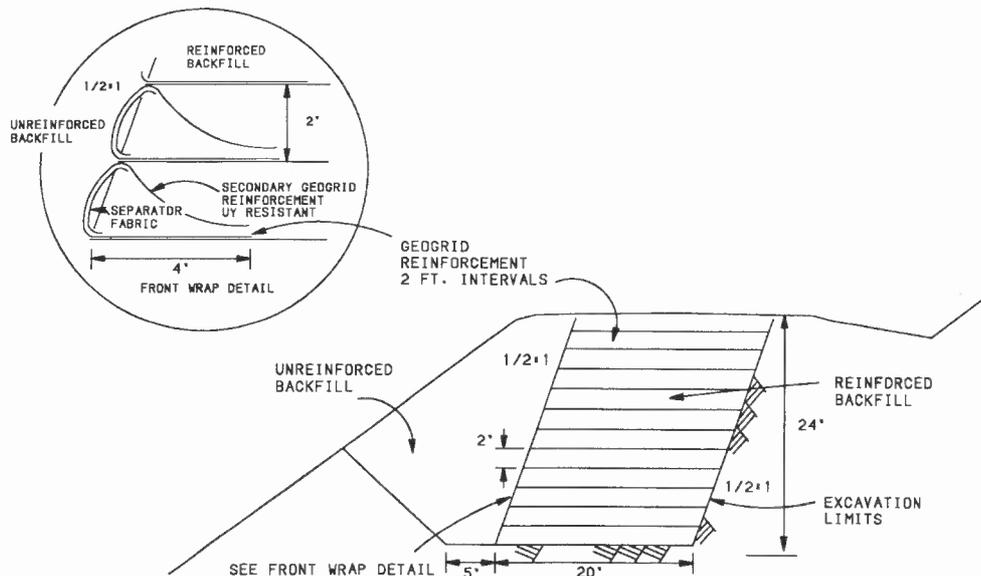
The problem of the slide movement at MP 18.66 was being compounded by a stream undercutting and removing material toward the base of the slide mass. During initial construction of this road, the stream was rechannelled away from the bank. After many years of eroding its way back to its natural channel, it began to cut away at the embankment built to support the road above. As erosion continued, the outlet section of a 48-in. culvert, 30 ft above the stream, lost support. This 8-ft section eventually fell off. The slope was gradually steepened to nearly vertical. MP 18.54 showed the same type of settlement of the pavement and shoulder as MP 18.66, but without loss of the side slope. Both areas had received as many as 14 in. of asphalt patches over the years.

FIGURE 6. Cross-section at MP 18.66, showing geogrid reinforcement in top 24 ft of roadway.

These two areas were repaired using a soil reinforcing geogrid fabric. The first area (MP 18.54) was 250 ft in length and required an excavation of 2400 yd³. It was reconstructed beginning at a depth of 12 ft with 10 layers of geogrid spaced 1 ft apart using backfill obtained from the opposite cut slope, after discarding large boulders and clumps of clay. The backfill was again obtained from the opposite cut slope. This area also contained a zone of unreinforced backfill on the outside of the reinforced area (Figs. 5, 6). Once begun, these two repairs took about 10 weeks to complete.
