SUMMARY OF ENVIRONMENTAL ISSUES AT EL MOLINO MILL, NORTH-CENTRAL NEW MEXICO

PEGGY S. JOHNSON and JUDITH L. DEEDS

Daniel B. Stephens & Associates, Inc., Albuquerque, NM 87109

Abstract—The El Molino mill, located northwest of the Village of Pecos, New Mexico, has been investigated as a potential hazardous waste site under the Comprehensive Environmental Response, Compensation and Liability Act, or CERCLA, since 1985. Under the CERCLA process, the New Mexico Environment Department has identified the mill site as an operable unit requiring a remedial investigation, a feasibility study, remedial design/remedial action, and long-term operation and maintenance of a remediation plan. Three tailing impoundments constructed adjacent to El Molino mill in Alamitos Canyon are in close proximity to schools and residential areas in Pecos and pose potential risks to human health from contaminated soil and ground water. The tailing materials, characterized by low pH values and elevated concentrations of metals, may potentially affect nearby soils, surface water, air quality, and ground-water quality in domestic and municipal water supplies.

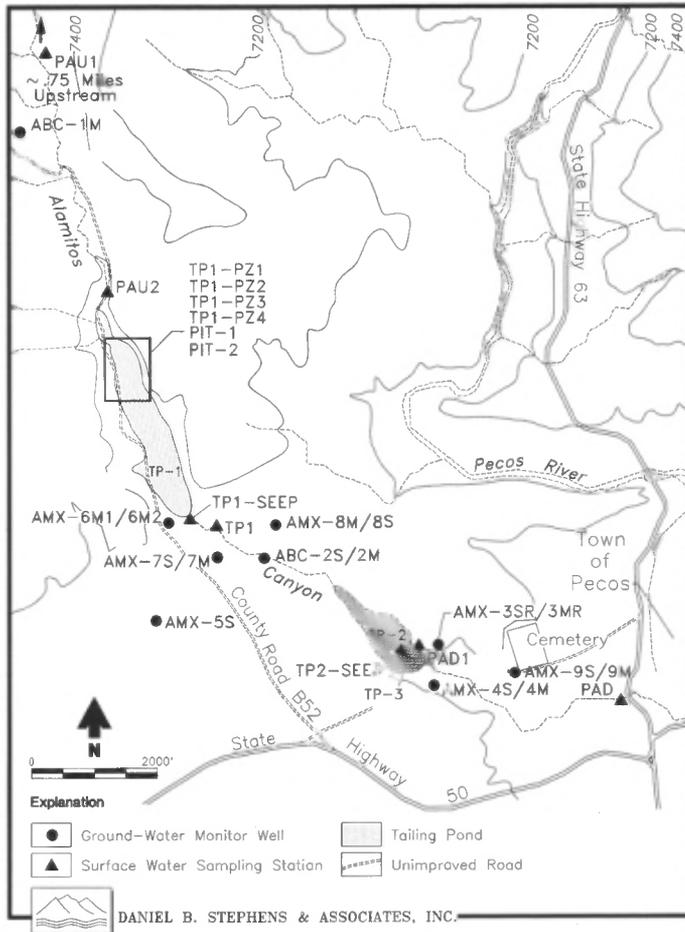
The El Molino mill operable unit (Fig. 1), located in Alamitos Canyon within the Bert Clancy Fish and Wildlife Area, totals approximately 47 acres. Associated with the mill are three tailing impoundments constructed along an intermittent stream in Alamitos Canyon (Fig. 2). The upper two tailing impoundments (TP-1 and TP-2) were deactivated in 1939 and have been slowly eroding since that time. The largest and uppermost tailing impoundment, TP-1, is 33 acres in area. The middle tailing im-

FIGURE 2. Water quality monitoring stations for El Molino mill.
