SUMMARY OF ENVIRONMENTAL ISSUES AT EL MOLINO MILL, NORTH-CENTRAL NEW MEXICO

PEGGY S. JOHNSON and JUDITH L. DEEDS

Daniel B. Stephens & Associates, Inc., Albuquerque, NM 87109

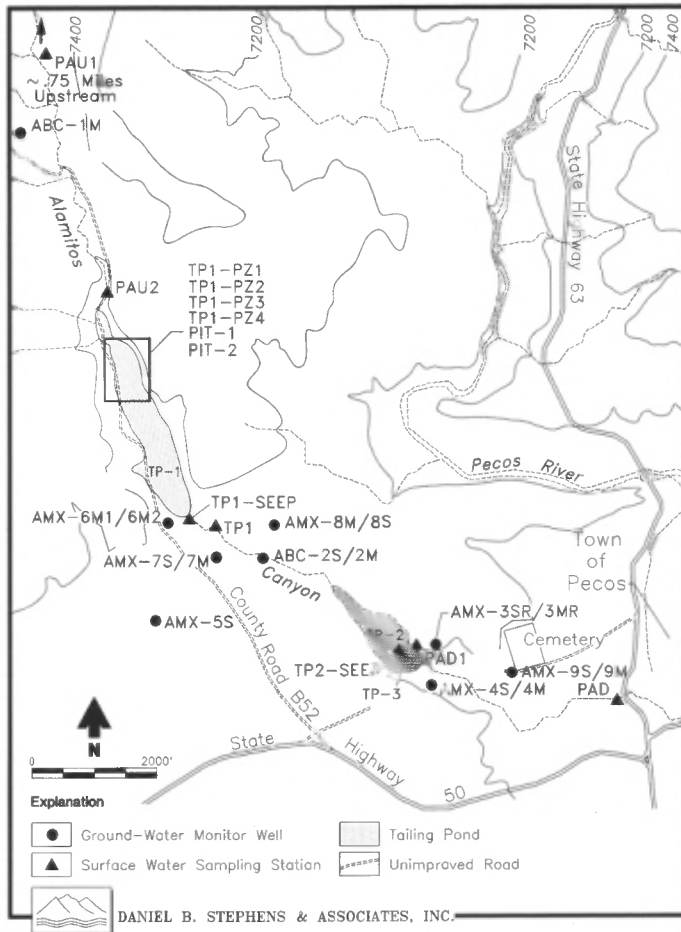
FIGURE 2. Water quality monitoring stations for El Molino mill.

The El Molino mill operable unit (Fig. 1), located in Alamitos Canyon within the Bert Clancy Fish and Wildlife Area, totals approximately 47 acres. Associated with the mill are three tailing impoundments constructed along an intermittent stream in Alamitos Canyon (Fig. 2). The upper two tailing impoundments (TP-1 and TP-2) were deactivated in 1939 and have been slowly eroding since that time. The largest and uppermost tailing impoundment, TP-1, is 33 acres in area. The middle tailing im-

The quality of surface water in Alamitos Creek has also been affected as it traverses the tailing impoundments. The surface water regulatory standards used to evaluate surface water quality are defined by a hardness-based calculation that establishes chronic toxicity for freshwater aquatic life (U.S. EPA, 1986). The calculated standard provides a value for dissolved metal concentration at a measured hardness that will not unacceptably affect freshwater aquatic organisms if a 4-day average concentration does not exceed the standard more than once every 3 years on the average. Cadmium and zinc have been detected in surface water downstream of TP-1 in concentrations elevated above background and also exceeding EPA criteria for fresh-water aquatic life (Table 2). Sediment samples from Alamitos Creek also show elevated levels of iron, copper, lead and zinc when compared to upstream samples. In order to mitigate surface water impacts and to prevent further stream water infiltration, seepage and erosion at TP-1, Alamitos Creek has been rerouted through a channel engineered with a synthetic liner.
