William J. Stone, 2001, pp. 317-319

# THE ENDEE PIPELINE LEAK — IMPLICATIONS FOR TREATING GROUND-WATER CONTAMINATION BENEATH THE GREAT PLAINS, EASTERN NEW MEXICO

WILLIAM J. STONE

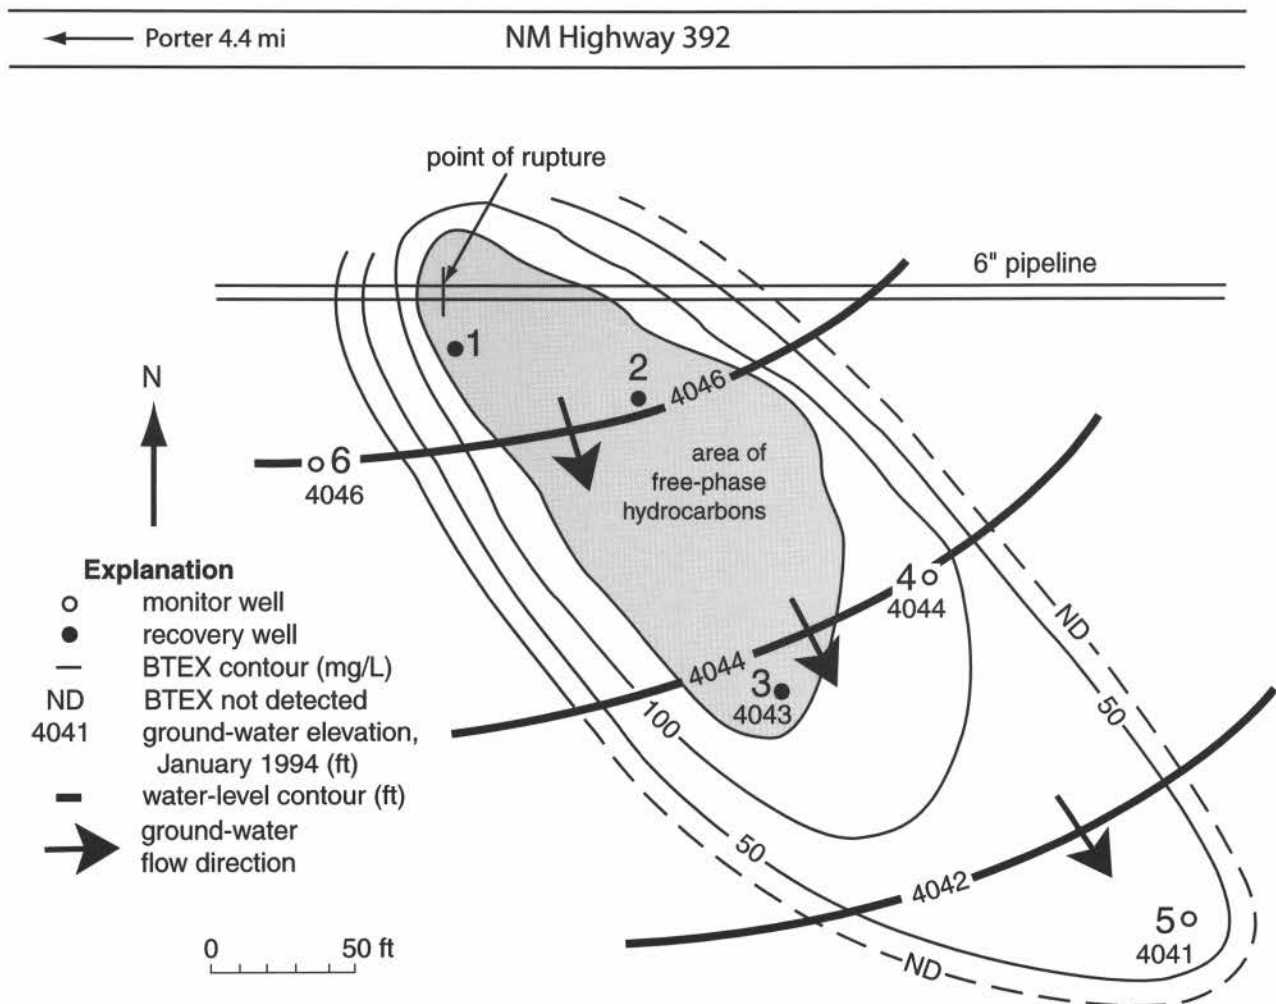
To define the nature and extent of the contamination, six monitoring wells were installed in and around the impacted area (Fig. 1). More specifically, five wells were located within the area of the surface plume (area of discolored soil) and one was located outside of that to the west. These wells revealed that there is a shallow body of saturation (16 – 36 ft below ground surface). This water appears to be perched on a well-cemented pebbly zone near the top of the redbeds (Stone, 1999). Water-level measurements suggest flow is southeasterly toward local drainage (Fig. 1).

Characterization of the subsurface plume was made possible by the six monitoring wells. Three of the wells located within the surface plume encountered up to 8 ft of free product floating on the perched water. The other two wells detected major fuel components (benzene, toluene, ethylbenzene and xylene or BTEX) at 11–311 ug/L in the perched ground water, but no free product. The extent of the ground-water plume was found to generally mirror that of the surface plume.

FIGURE 1. The Endee pipeline leak site, Quay County, New Mexico (constructed from figures in NMED files). BTEX contours are from October, 1996 measurements.

Product remediation was undertaken by means of a solar-powered recovery system. This involved outfitting initially two and eventually all three of the wells that penetrated free-phase hydrocarbons with pumps (Fig. 1). The pumps are connected to a storage tank that is emptied periodically. Recovered product is taken to a plant in Tucumcari for oil/water separation and appropriate reclamation. Until March 1994, only free product was collected by the recovery system (Table 1). Thereafter, quantities of water, sometimes exceeding those of product, were also produced. By 1995, more than 5,000 gal of fuel had been removed from the ground. Product-recovery efforts continue today.
