THE RIO SALADO AT FLOOD

ALISON C. SIMCOX

INTRODUCTION

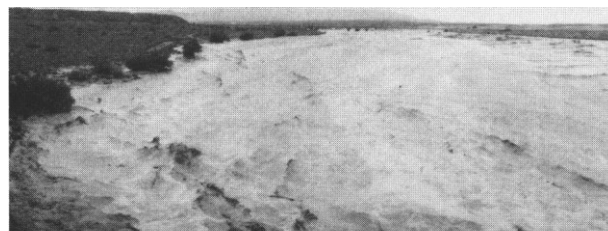
Figure 3a. Upstream view of the flood of September 21, 1982, taken from the I-25 bridge. The gauge station and tamarisk trees at the location of bridge pilings for old U.S. 85 are just visible at left middle ground. Photo by Douglas Heath.

Figure 3a is an upstream view of the September 21 flood from the south end of the I-25 bridge. Figure 3b was taken from the same vantage point about a month later.

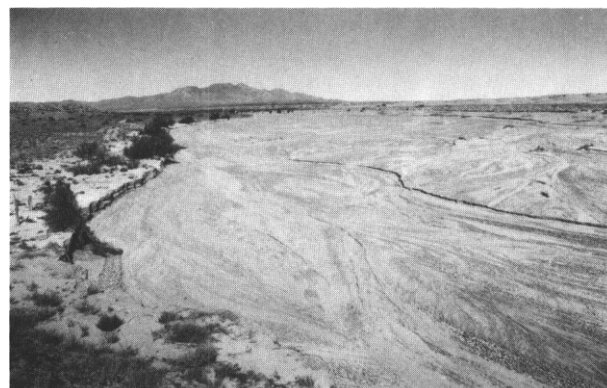
Figure 3b. View of the Rio Salado taken from the same vantage point a month later. Photo by David Love.
