Clayton Lake Dinosaur Tracksite - Surface Hydrology Analysis

Establishing a baseline for studies of surface erosion

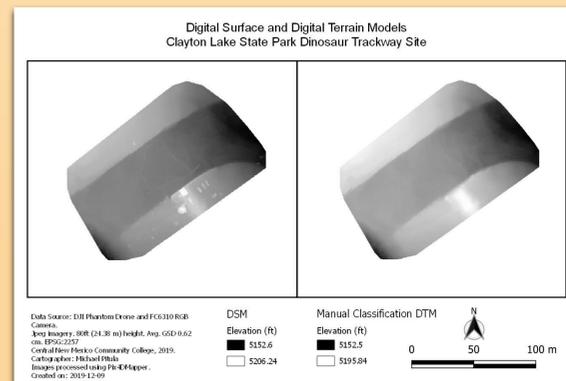
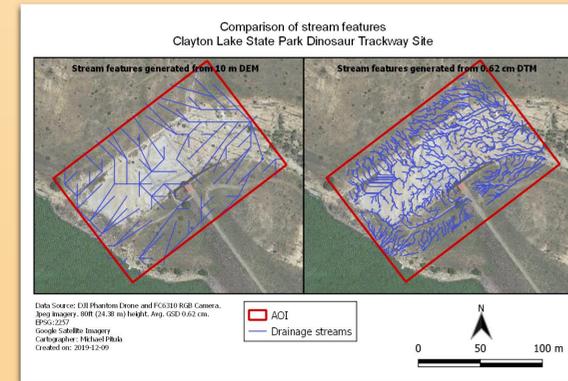
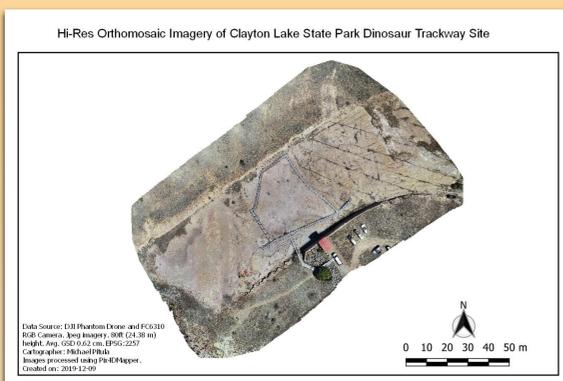
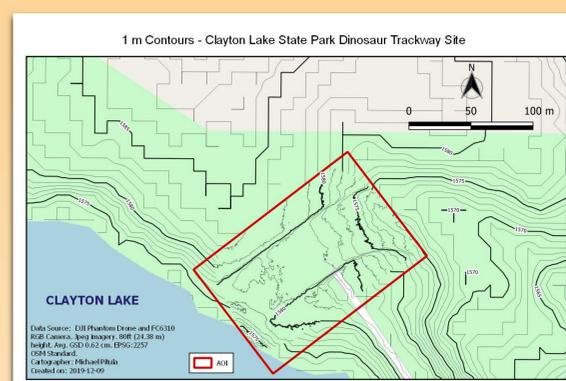
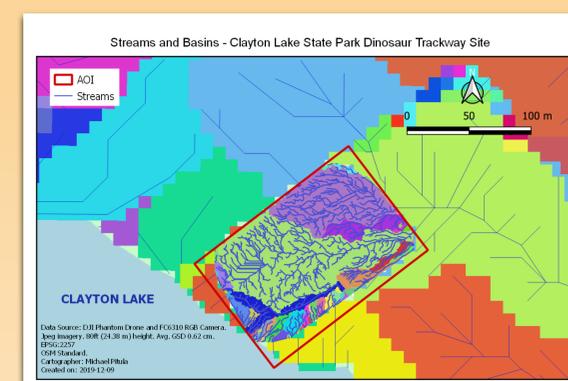
ESRI ArcMap 10.6 Modelbuilder and QGIS 3.x were used to conduct a hydrological analysis of the site topography based on the DTM. This process generated feature classes for basins, contours and ephemeral microstream features. These were then intersected with the microstreams with the exemplary tracks. These tracks are potentially the most impacted by surface runoff because velocity of runoff is higher in the relatively narrow channels.

Access to subcentimeter spatial resolution imagery greatly enhanced our perspective on this site. Drainage is now characterized with much greater accuracy, which is crucial in relation to the scale of these trackways. The surface runoff flows across the spillway toward the northeast, away from the lake, whereas flow direction modelling based on 10m DEM's indicated a greater degree of flow back into the lake. The analysis determined that about half of the exemplary trackways are intersected by ephemeral microstreams. Many of these are simply grazed by the microstreams but about 3-4 of them are squarely intersected by drainages that accumulate from significant upstream areas within the watershed. These are tracks that should be prioritized for protection.
