Rebecca Moskal, Daniel Cadol

New Mexico Institute of Mining and Technology, Socorro, NM

The Arroyo de los Pinos is a tributary of the Rio Grande that transports tons of relatively coarse sediment into the river annually through flash flood events. The focus of this research is to determine where sediment erodes and deposits in the arroyo reach leading into our monitoring station and to document how much enters the Rio Grande. To investigate this, we have started using Structure from Motion (SfM) photogrammetry from drone-based air photos that are then analyzed in a program called AGISOFT. This allows us to create digital elevation models (DEMs) that we can then use to create a digital elevation model of difference (DoD) which shows the difference between two DEMs and quantifies the deposition and erosion. Comparing DEMs and DoDs from previous years to our most recent DoD shows that the bed surface became flatter in the arroyo due to the flash flood events of this past monsoon season.

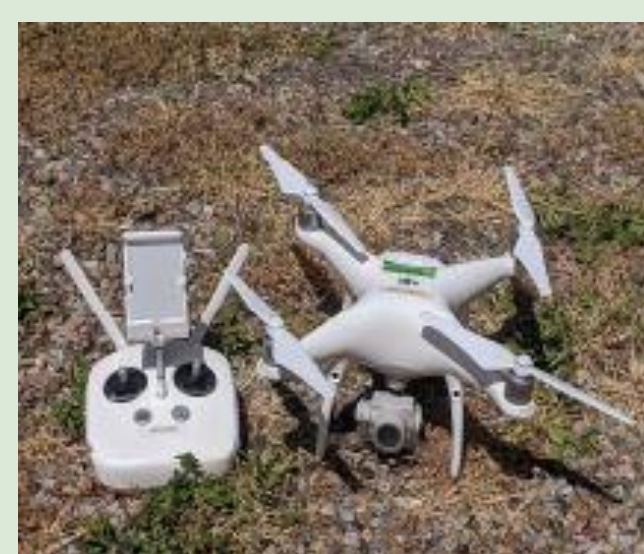
DJI Phantom 4 drone

- Field work consisting of flying a drone and surveying ground control points
- Running the program AGISOFT to assess the quality of the photos and do data post processing
- Create a sparse point cloud and add ground control points
- Create a dense point cloud
- Use the dense point cloud to create a DEM

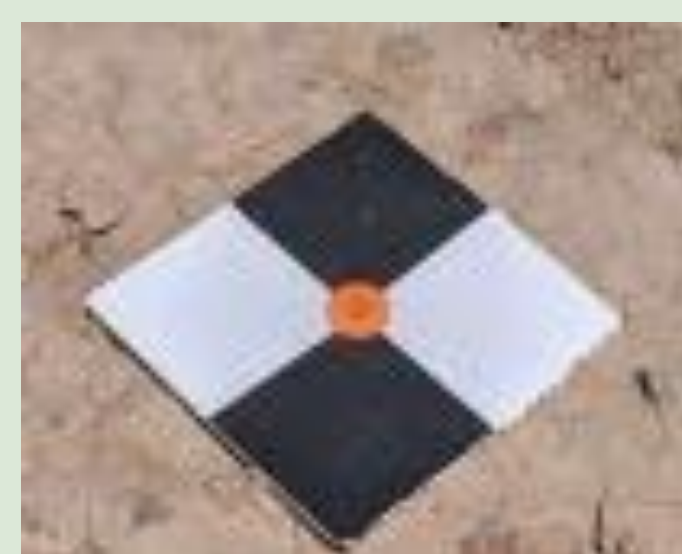
A target used as a ground control point

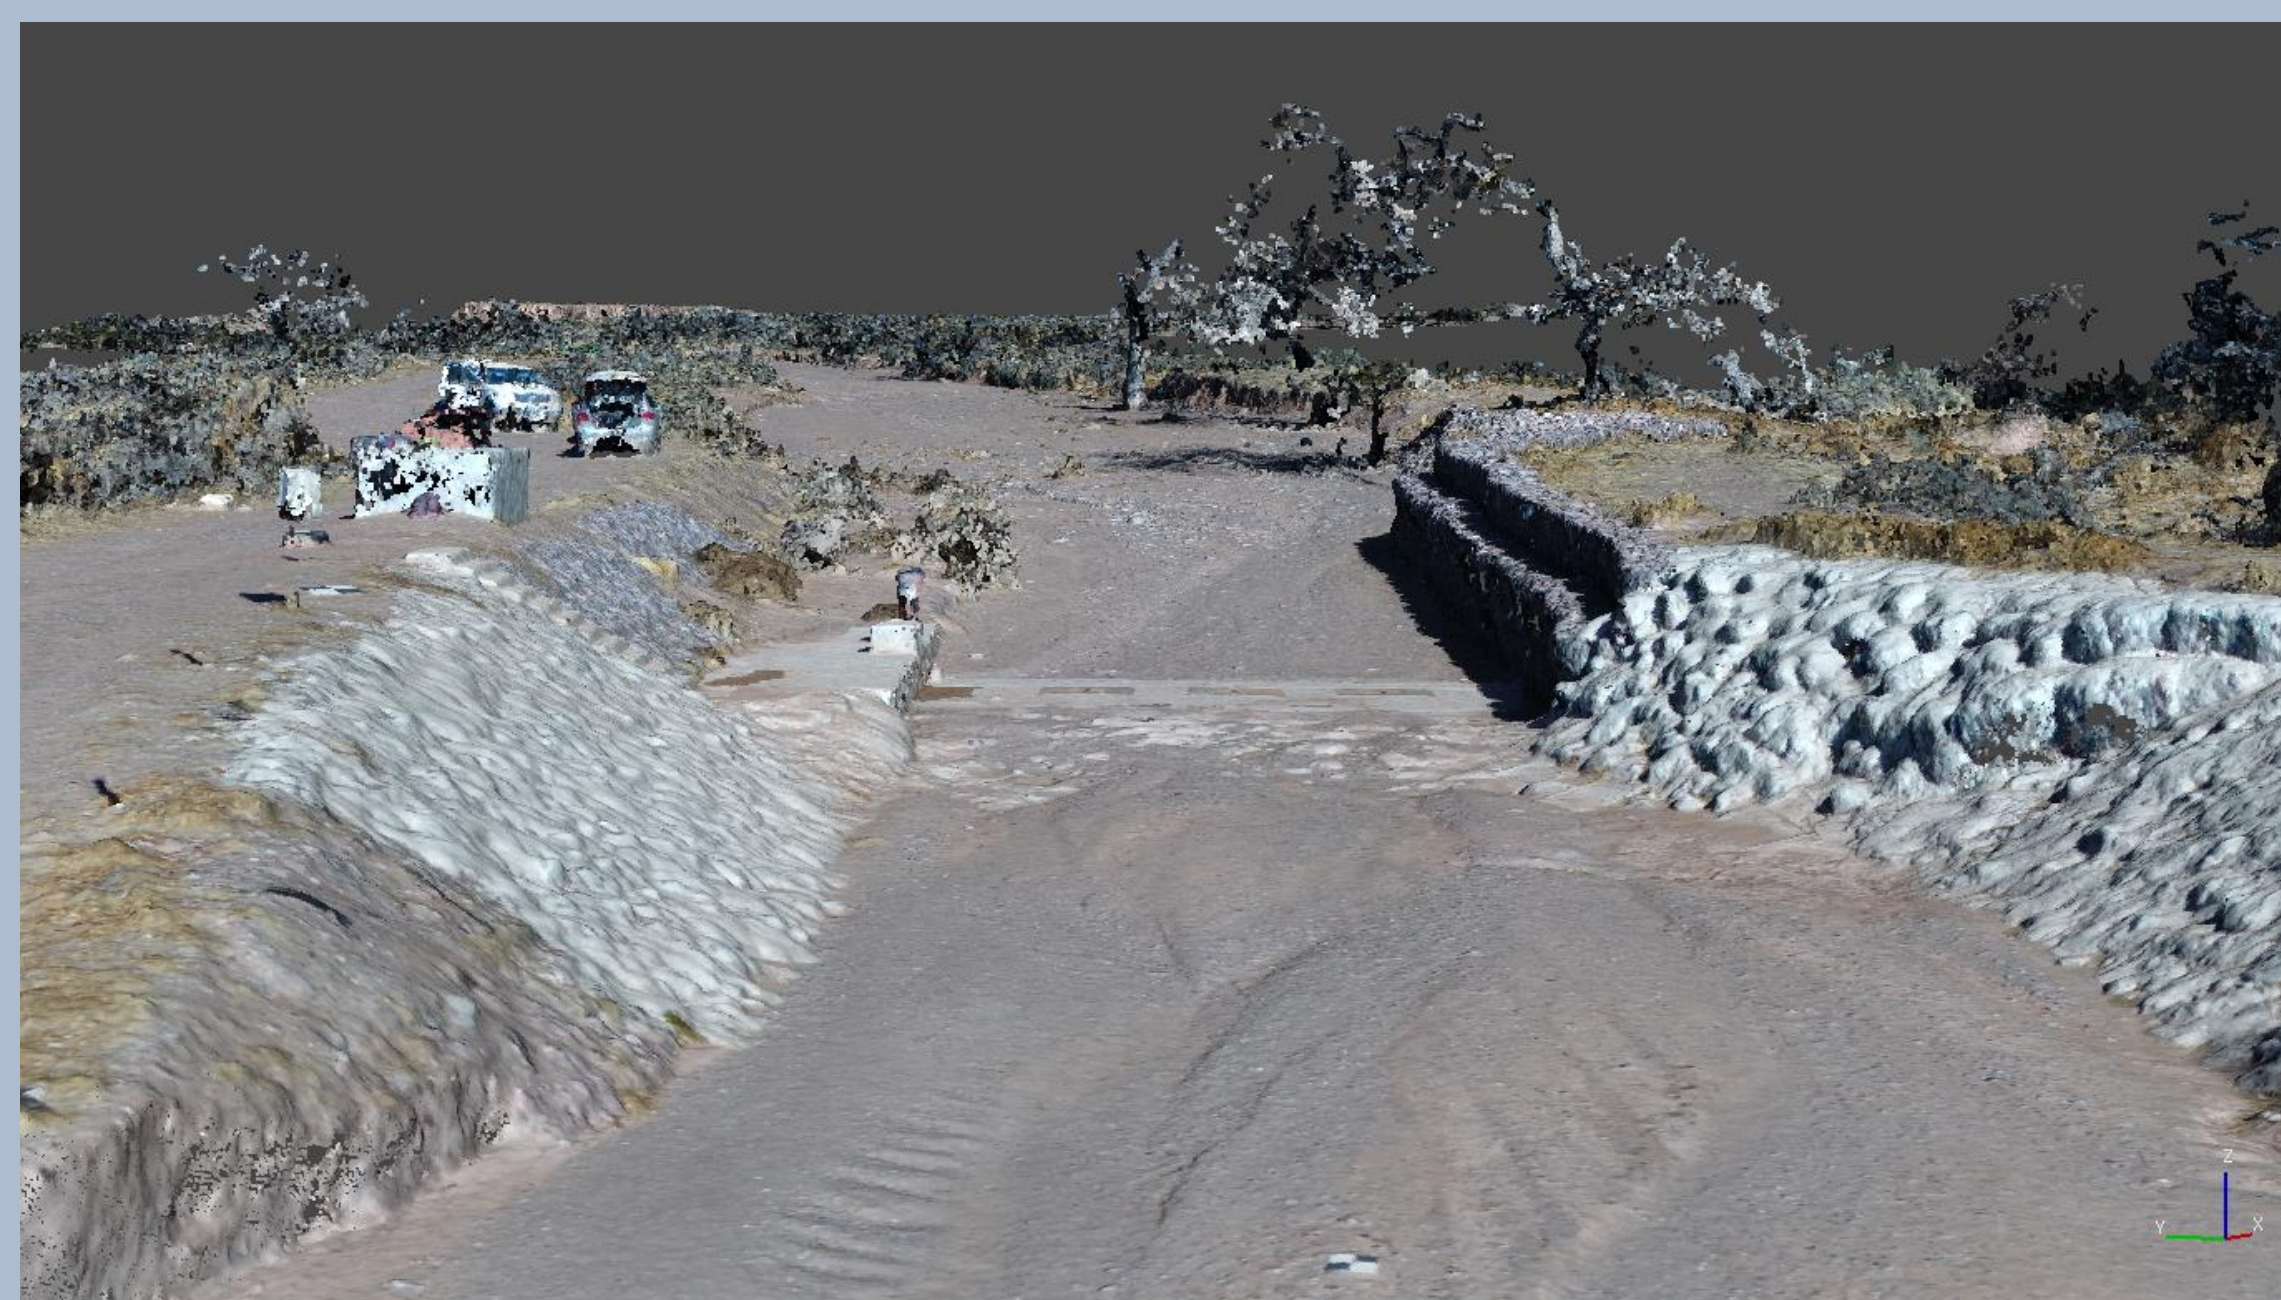
Dense Point Cloud

- This is a dense point cloud which is generated by running drone pictures through AGISOFT and creating a sparse point cloud.
- View of the Pinos monitoring station as a dense point cloud.

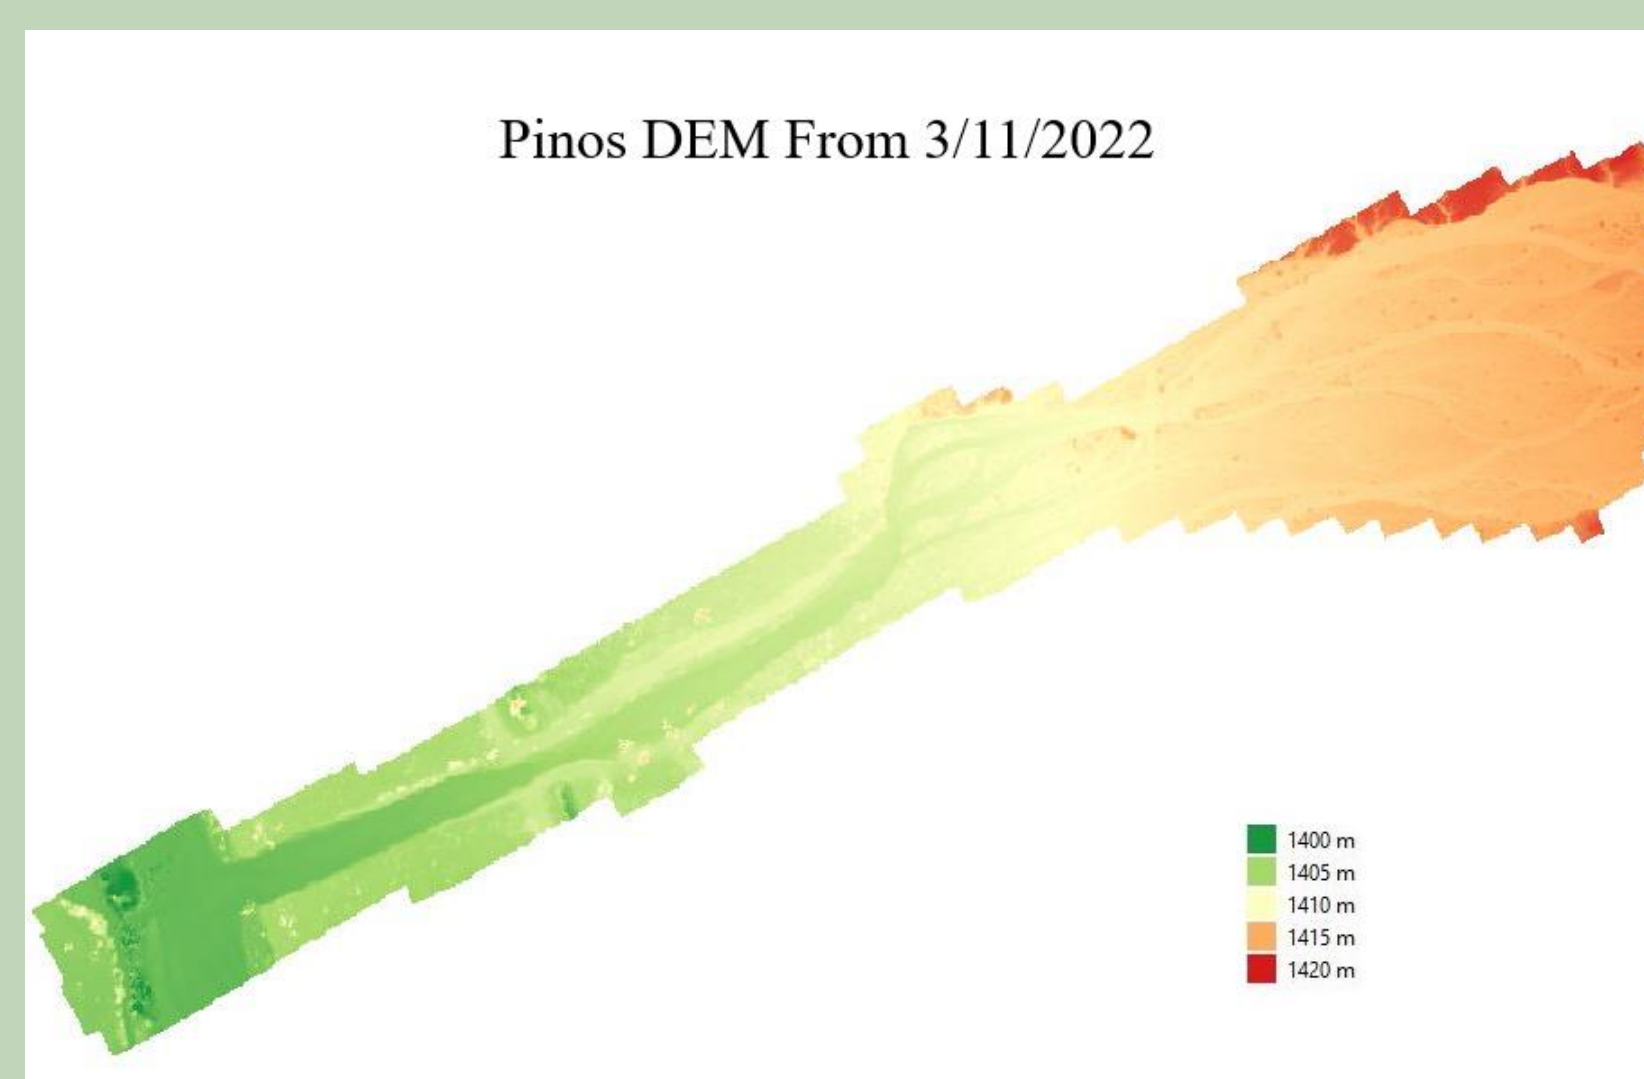
A DEM created at the end of the 2021 monsoon season by Rebecca Moskal.

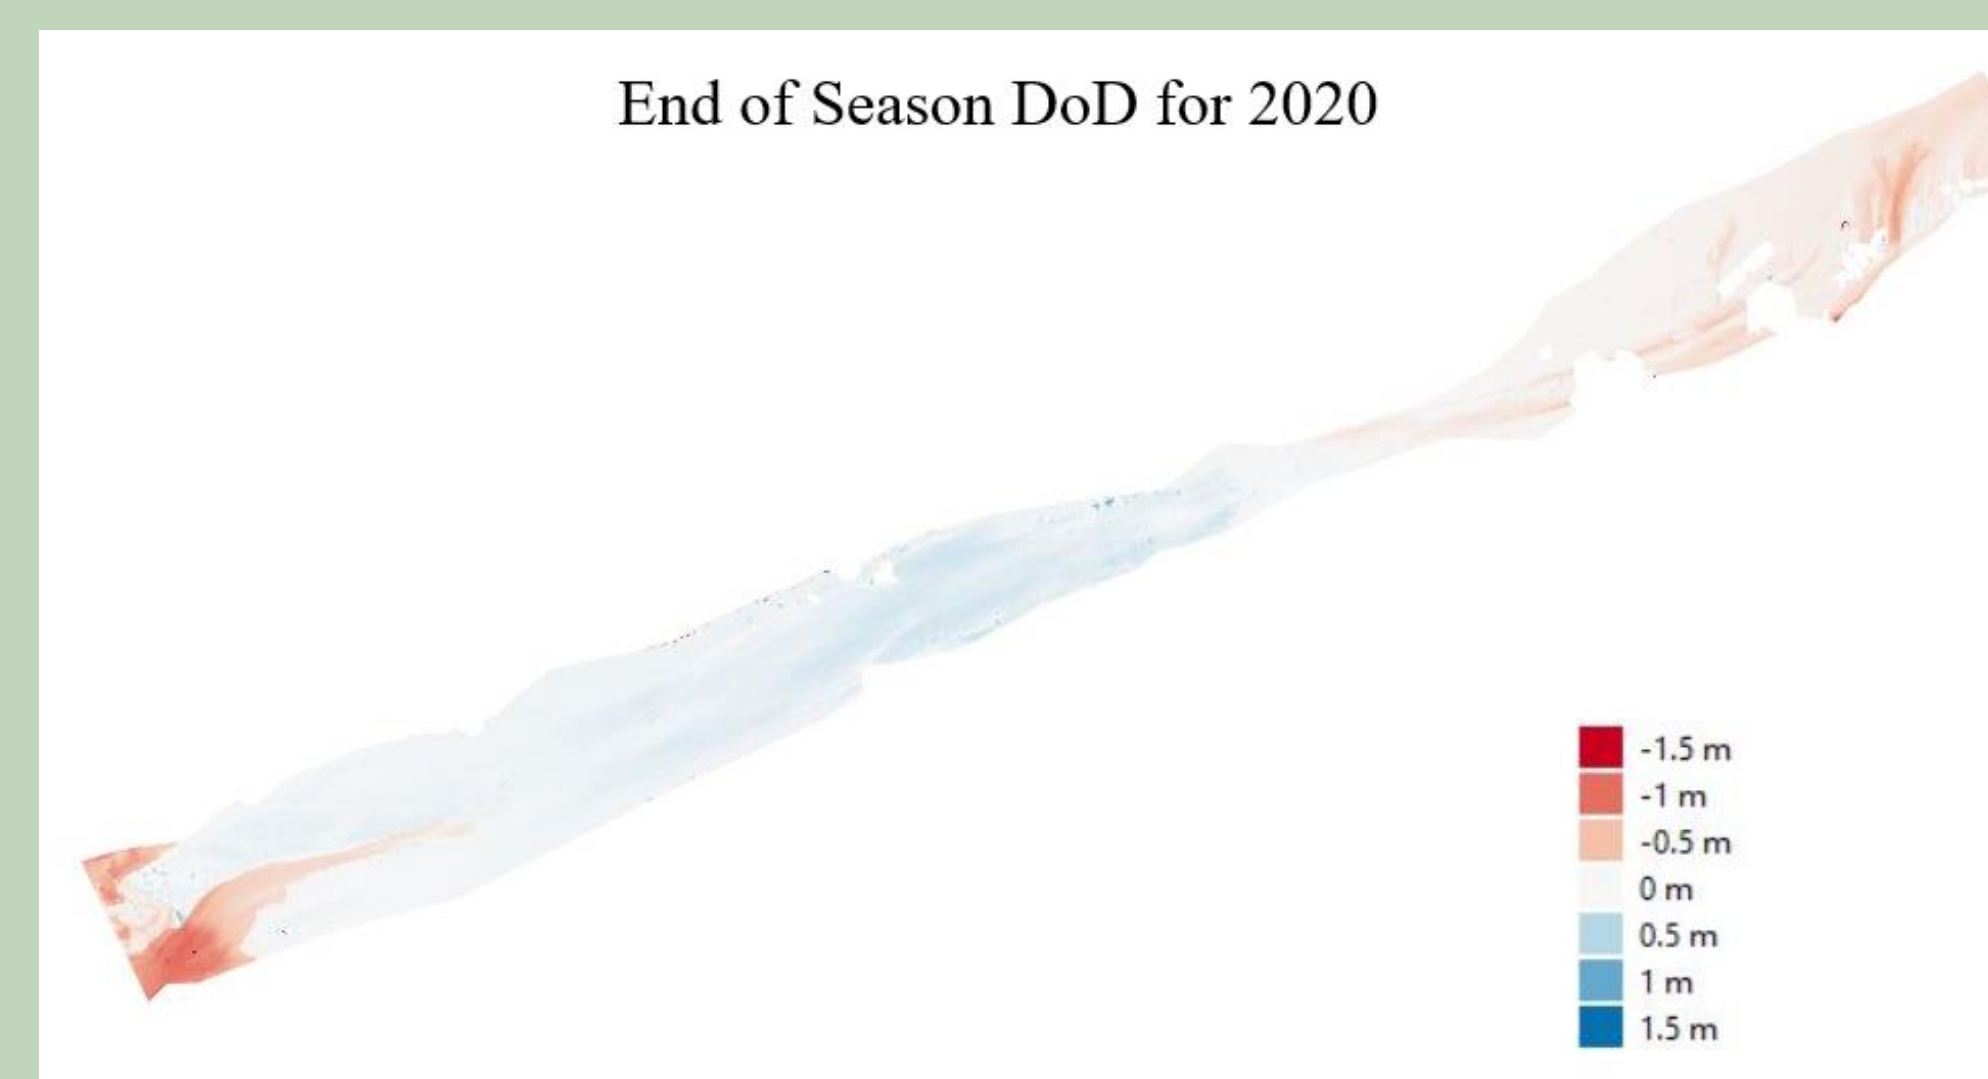
A DoD from the end of the 2020 monsoon season. This is useful to compare to the 2021 end of season DoD above to understand how the channel changed over the span of the year.
