THE AGUIRRE SPRING DEBRIS FLOW OF AUGUST 14, 1991

LORETTA M. HECKMAN¹ and JERRY E. MUELLER²

Abstract—A meso-scale convective storm in the White Sands-Aguirre Spring area during the late evening and early morning hours of August 13–14, 1991, initiated a major flow event in the basin of Anvil Creek, a long, narrow watershed that heads just below the Needles on the east side of the Organ Mountains. Field evidence indicates that the flow in its upper reaches was confined to the north branch of Anvil Creek where the channel was greatly modified and enlarged, producing a chute-like bed of polished bedrock. At the lower end of the bedrock channel, the flow followed the natural bend of the north branch to the north-northeast, depositing a viscous lobe of boulders encased in a matrix of gravelly grus. A subsequent flow failed to negotiate the turn, instead surging ahead to enlarge a breach in a narrow divide between the north branch and south branch of Anvil Creek. Cross-sectional measurements of the active channel of Anvil Creek upstream of the breach produce estimated peak water discharges that are unrealistically high for such a small basin. In addition, there is no evidence for major

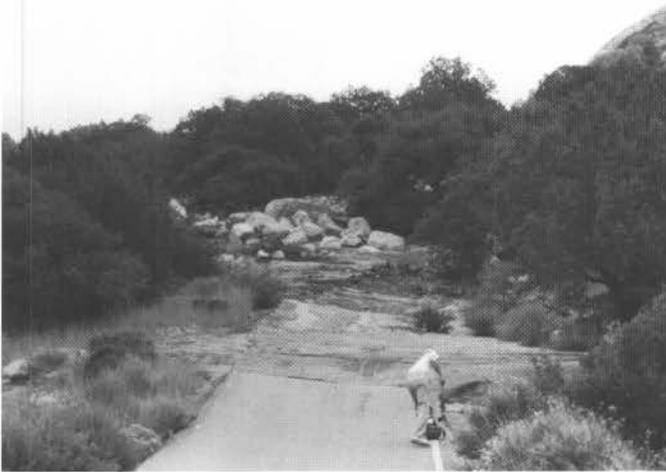
FIGURE 1. Loop road through the Aguirre Spring Recreation Area as it appeared in middle September, 1991, one month after the major flow event. The sand, gravel, and vegetation debris in the foreground are associated with the now largely abandoned north branch of Anvil Creek. The boulder accumulation in the background is associated with the south branch or major active channel of Anvil Creek.

was blocked by an accumulation of massive boulders and debris (Fig. 1). A reconnaissance by BLM personnel revealed that a major flow event had heavily scoured the banks and bed of Anvil Creek, built rock levees both upstream and downstream of the loop road, and inflicted serious damage to the lower campground area (Fig. 2). The south branch of Anvil Creek contributed mostly boulders, whereas the north branch contributed water that splayed sand and gravel across the road.

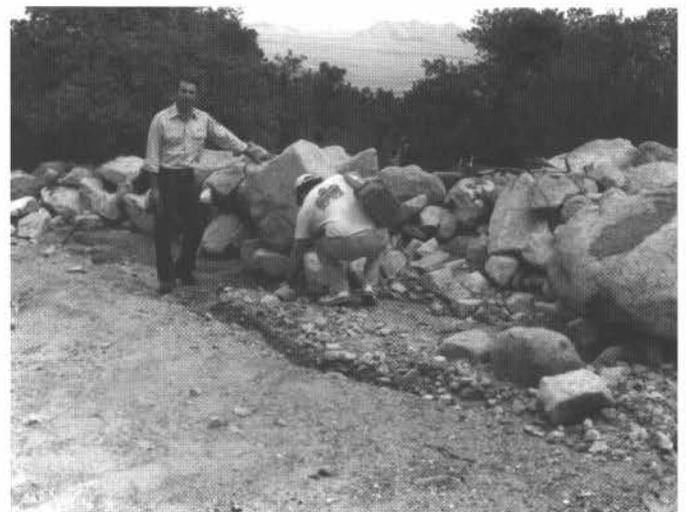
FIGURE 2. Marginal rock levee that formed between the channel and an interior road within the lower campground. Between the two people a precariously balanced tabular rock is standing on end. The direction of flow was from right to left.

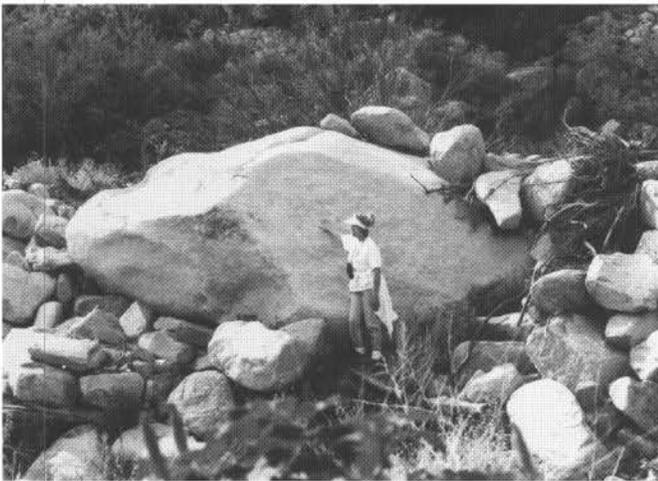
FIGURE 4. The largest boulder along the lower active channel of Anvil Creek. It is positioned on top of a major rock levee and probably moved a short distance during the 1991 flow event. View is to the south just downstream of the breach. Direction of flow is from right to left.

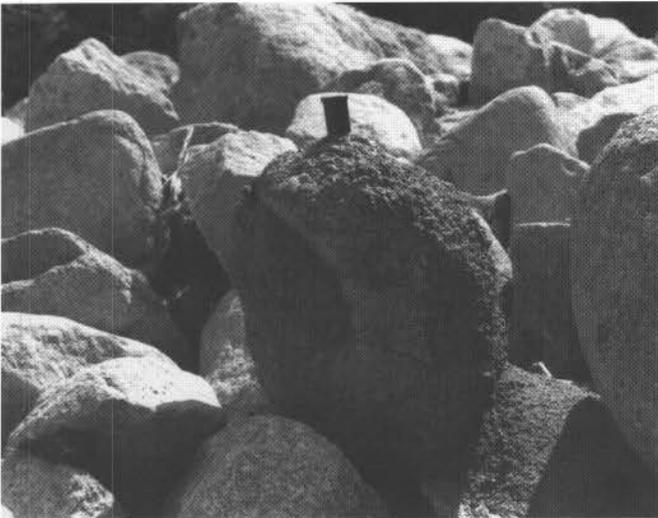
FIGURE 7. Thoroughly weathered corestone resting on top of large fresh boulders of mid-lobe region. Granular disintegration began almost immediately after the corestone was exposed at the surface. No trace of the corestone was found in 1996. Film canister for scale.

A small, 1.5-ft diameter, chemically and concentrically weathered marginal corestone was centrally located and balanced atop and among the largest of the fresh, angular boulders (Fig. 7). This corestone attests not only to the mechanics of a debris flow, but also to the weathering and erosional processes which transformed the rock itself (Durgin, 1977). This altered rock would qualify, according to Durgin (1977), as a 60% chemically weathered corestone, the second stage in the erosional evolution of a granitic terrain. Corestones can range from 15–85% weathered material before breaking down to a third stage called decomposed granitoid or *grus*. In the decomposed granitoid stage, the mass is very friable due to its 85–100% alteration. There was no trace of the corestone at Aguirre Spring in 1996, an indication of the rate of granular disintegration once the corestone was deposited and exposed on the surface of the lobe.

If, as Durgin (1977) proposes, debris-flow movement is related to the decomposed granitoid stage, then this small but very important piece of evidence argues convincingly for a debris flow as opposed to a water flood. This corestone, marginal to a decomposed granitoid, must have been rafted in a viscous, laminar flow, because a turbulent flood and the very large rocks with which the corestone was found, would have crushed such a small and friable mass. This evidence, combined with the evidence at the head of the lobe for a proportionally higher amount of decomposed granitoid, suggests that large amounts of *grus* were initially deposited as part of the lobe. Later, however, some of the *grus* was winnowed out by surface runoff and redeposited downstream ahead of the lobe.

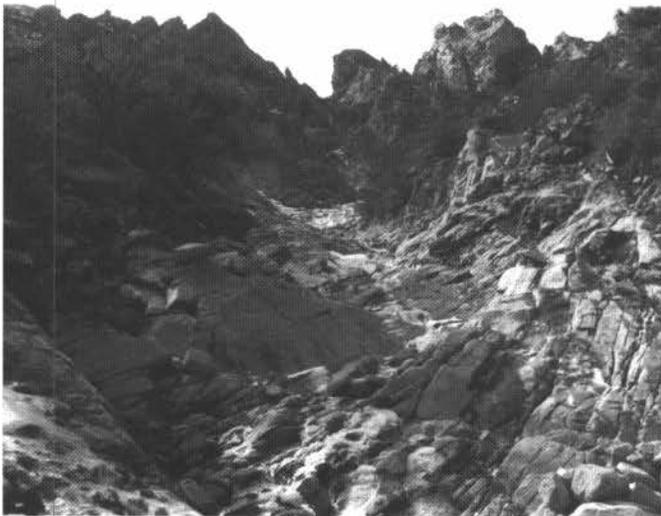
FIGURE 9. View upstream along the main stem of the active channel. The chute-like appearance of the channel and the polished bedrock floor suggest recent grinding by a viscous flow.

Between elevations 7400 and 6500 ft, the active channel is cut across Tmo and Tmps. This main stem begins as an open chute-like channel and becomes progressively incised in the downstream direction (Fig. 9). The bedrock exposed on the channel floor and walls is everywhere highly fractured by steeply-inclined joint sets. Above the bedrock in the valley walls is a deep regolith of grus, corestones, and boulders. The channel floor, by contrast, has been swept clean of almost all boulders and debris associated with the 1991 flow event. The most unusual feature of this entire reach is a large isolated boulder along the south margin of the channel. This boulder, estimated at several hundred tons, was overridden by the 1991 flow event but was not mobilized. Although it was scoured and cleaned on its upstream face and sides, its downstream side remains covered by lichens and an organic soil.

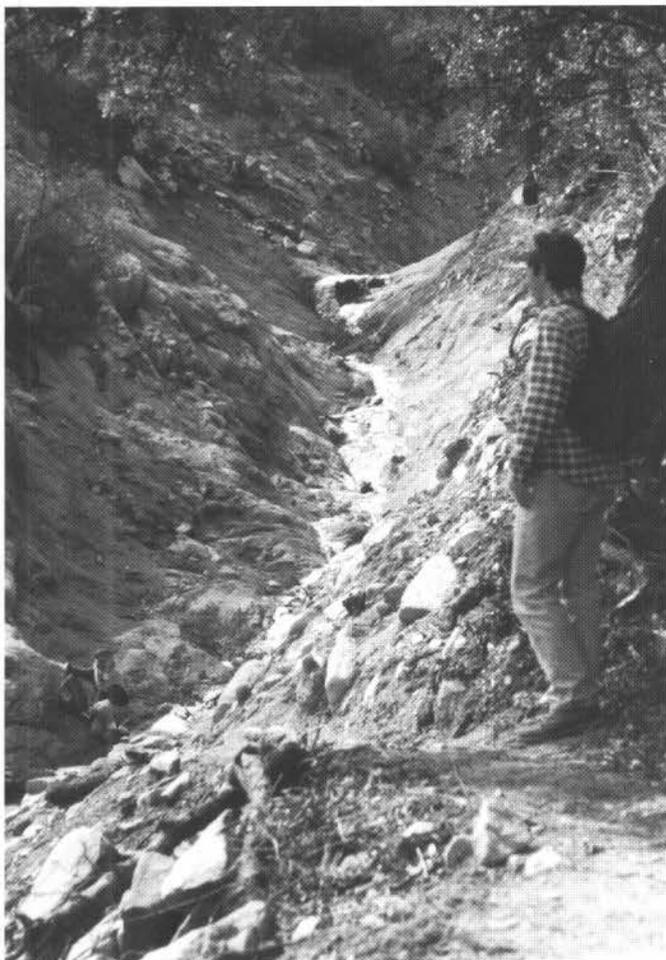
FIGURE 10. Pine Tree Trail where it crosses Anvil Creek, just upstream from a major knickpoint developed at the contact between bedrock and unconsolidated deposits. The thick regolith in this portion of Anvil Creek basin could serve as a source for future debris flows.

The active channel intersects Qcrp at an elevation of 6550 ft. The Pine Tree Trail crosses the active channel from north to south near the head of unit Qcrp, at an elevation of 6525 ft (Fig. 10). Immediately downstream of the trail crossing, the active channel displays a prominent knickpoint. Flows from the bedrock channel above plunge into and undercut the older fan materials below, producing steep valley sidewalls of exposed gravelly grus and partially decomposed boulders. From here to the lower end of the bedrock channel near the breach, the active channel displays alternating reaches of bedrock (Tmps) and debris. It is clear that the 1991 flow event entrenched the active channel but not its tributaries. As a result, several knickpoints have developed at tributary junctions. Other knickpoints have developed due to differential erosion of the bedrock channel floor. At a point approximately 900 ft upstream of the lower end of the bedrock channel, a knickpoint has developed along a 6-ft high boulder dam. Also conspicuous along this reach are sharply defined marginal levees and in situ boulders that are considerably larger than those carried by the 1991 flow

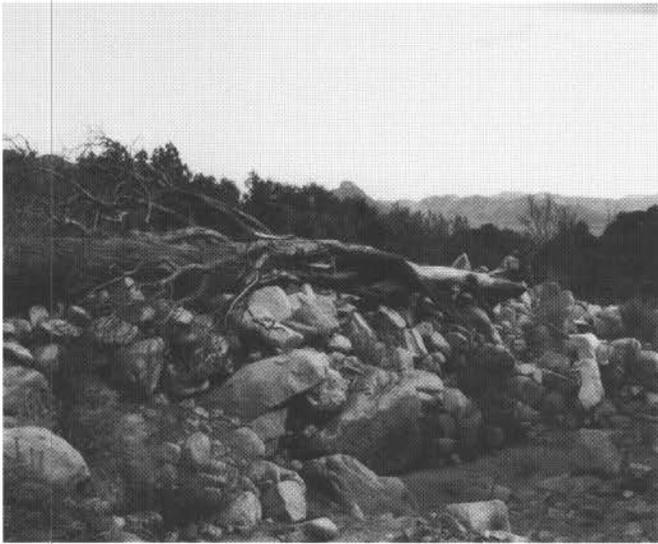
FIGURE 11. Marginal rock levee along the west bank of the lower active channel of Anvil Creek, approximately midway between the breach and the loop road. Although the large tree was rafted a considerable distance, its bark and branches survived mostly intact.

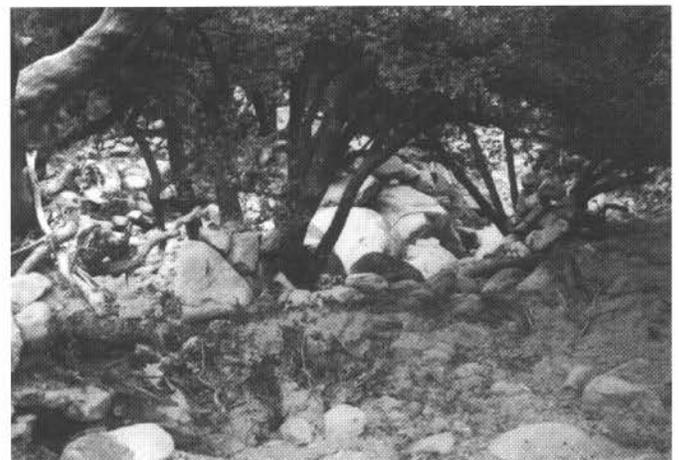
FIGURE 12. Oak trees in the lower campground engulfed by, but not damaged by, boulders of the 1991 debris flow deposit. The direction of flow was from right to left.

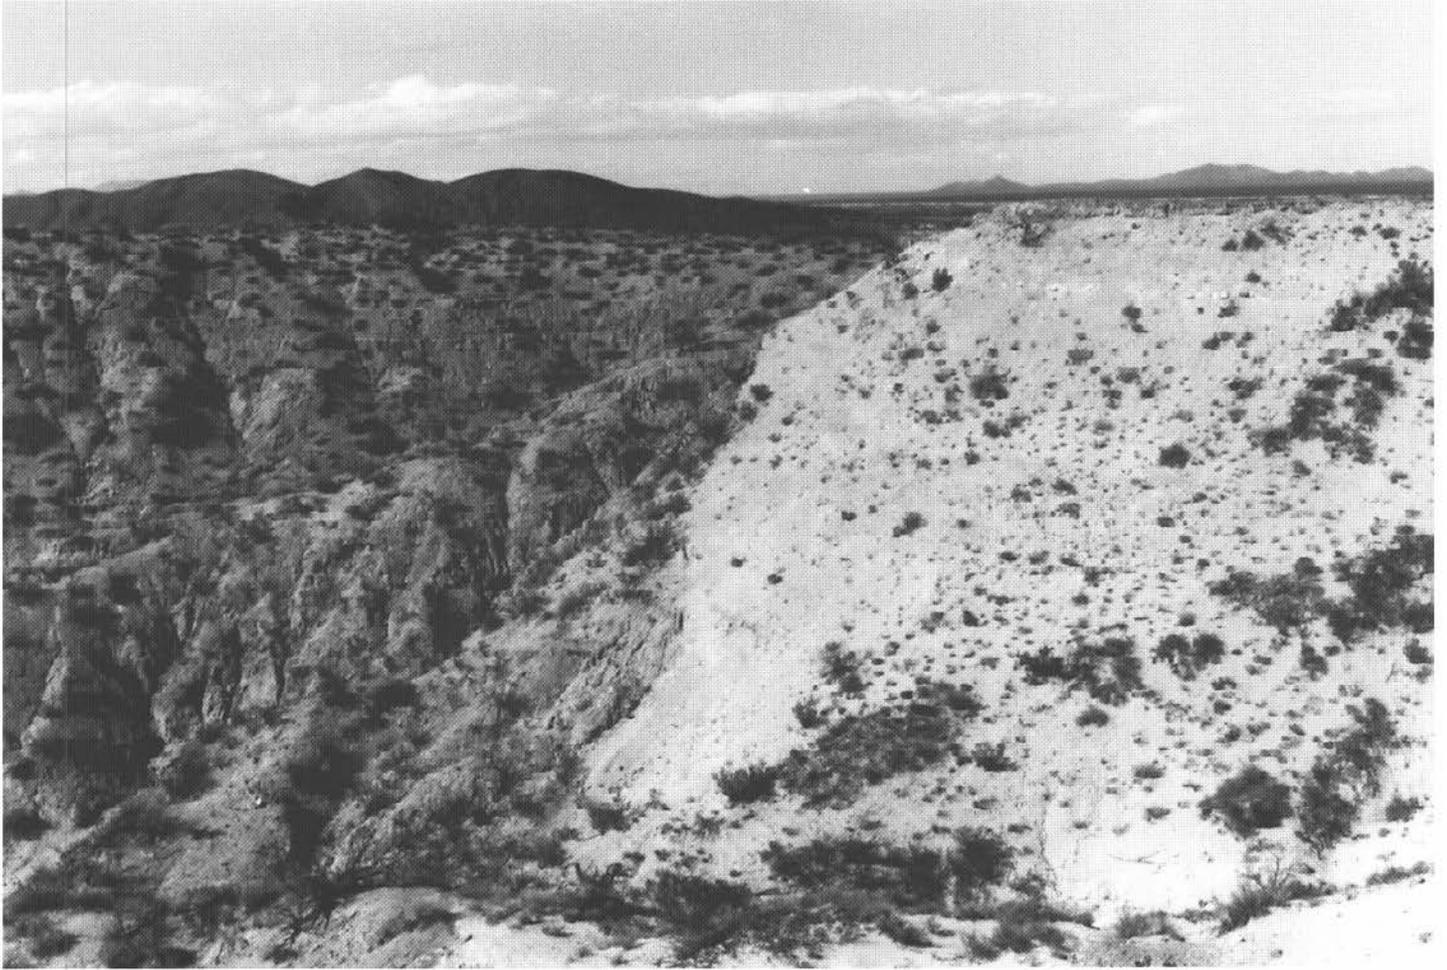
View looking north of the East Tonuco fault of Seager et al. (1971) south of San Diego Mountain. Perspective makes the fault appear to dip to the west (left), but it actually dips approximately 80° to the east (right). The fault offsets the Plio-Pleistocene Camp Rice Formation, placing axial-fluvial sediment on the hanging wall (right side). The East Tonuco fault probably connects southward with the Jornada fault, the main border fault of the Doña Ana Mountains. Photograph by Greg Mack.
