UNCOMMON TWENTIETH-CENTURY STREAM BEHAVIOR OF LOWER ABO ARROYO REVEALED BY FLOOD DEPOSITS AND HISTORIC PHOTOGRAPHS

DAVID W. LOVE AND ALEX J. RINEHART

New Mexico Bureau of Geology & Mineral Resources, 801 Leroy Place, Socorro, NM 87801

ABSTRACT—Widely scattered coal and clinker clasts and flotsam, combined with historical photos, and modern observations in the lower Abo Arroyo indicate valley-wide flooding and significant changes in sediment transport and channel erosion during the 20th Century. Coal and clinker granules and pebbles (2- to 40-mm diameter) as well as flotsam of whole juniper trees and other wooden debris along the valley floor of Abo Arroyo show that the valley was inundated by one or more large floods. Aerial photos taken in 1935 show widespread dark deposits along the valley floor. These dark deposits are believed to be coal that came from spills along the Atchison, Topeka and Santa Fe (AT&SF) Railroad through Abo Pass to the east. The railroad was built between 1903 and 1908, when the first timetable for the route was published. Prior to 1935, the most likely period for extensive flooding was in August and September of 1929, when regional storms and flooding oc

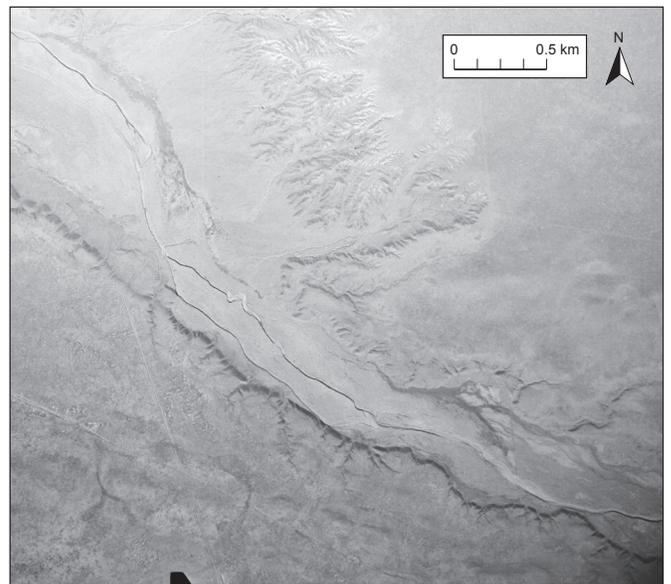
FIGURE 13. 1947 aerial photo of Abo Arroyo channels along the lower Abo Valley (6-10 km east of Veguita) compared with Figures 6 and 7. Channels appear to be deeper and more dominant, although one reach on the west side appears to be shallow and feeds a local headcut downstream. Scale is approximate because photograph is distorted, not rectified.

West-northwest of County Road 220, the arcuate channel reaches and broader meanders were similar to those in 1935. In 1947, the channel was much more defined between County Road 220 and the area of Figure 7 than it was in 1935 (Fig. 13); here, it extended downstream across its former fan about 2.5 km (Fig. 13, junction of two channels, left center; 344100 E, 33818875 N). Farther downstream (at 344175 E, 3819104 N), where in 1935, the arroyo had spread out onto the valley floor southwest of the present channel, a pair of tight meanders now occupied a reach that had formerly exhibited very low-sinuosity fan channels. Downstream from there, the channel occupied a former trail or road in a discontinuously incised reach to 340395 E, 3821049 N, where it then spread out as a gully-mouth fan (light sediment, left central part of Fig. 14). Many yazoo areas of dark gray coal/vegetation are still seen on the 1947 aerial photographs, although the fan at (340395 E) appears to bury the older dark gray sediments, and the ponded sediment in the tributary valley to the north appears to be covered with lighter-colored sediment on its south end.

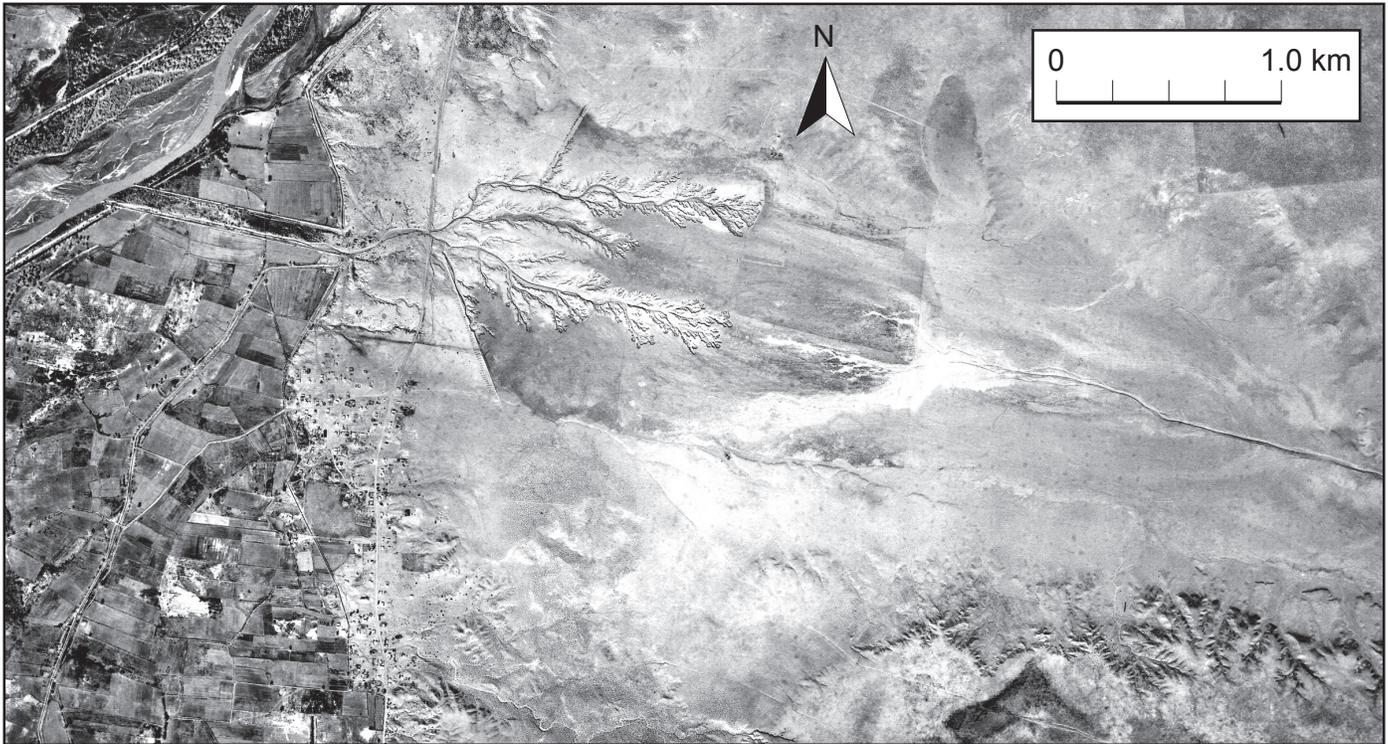
FIGURE 14. Aerial photo of lower Abo Valley and Veguita in 1947. Note several diversion dams near the headcuts and the distributaries at the mouth of the incised channel. Obviously, part of the incised channel follows a very straight road or trail. Scale is approximate because photograph is distorted, not rectified.
