# GEOMORPHIC EFFECTS OF STREAM CHANNELIZATION ON THE RIO PUERCO NEAR LA VENTANA, NEW MEXICO, USA

KEVIN M. HOBBS<sup>1</sup>

**ABSTRACT**—In 1965, the New Mexico Department of Transportation channelized a 3.4-km section of the Rio Puerco near La Ventana, Sandoval County, New Mexico, with an artificial, straight 1.7-km-long channel to facilitate new highway construction. The channelization nearly doubled the slope of the stream while reducing the hydraulic radius of the channel. Geomorphic adjustments in the channelized reach were drastic and rapid, including incision, widening, and development of meanders. In 2006, after the channelized reach had incised to depths of at least 15 m, widened to at least 105 m, and developed a meander that threatened U.S. Route 550, the river was rerouted back into its natural channel. During the four-decade lifespan of the channelization, an estimated  $6.2 \times 10^5$  m<sup>3</sup> of sediment was removed via erosion and delivered down the Rio Puerco. The sinuosity of the channelized reach increased from 1.000 to 1.093. Headward migration of a knickpoint in the channelized reach was retarded only by the presence of resistant bedrock underneath al

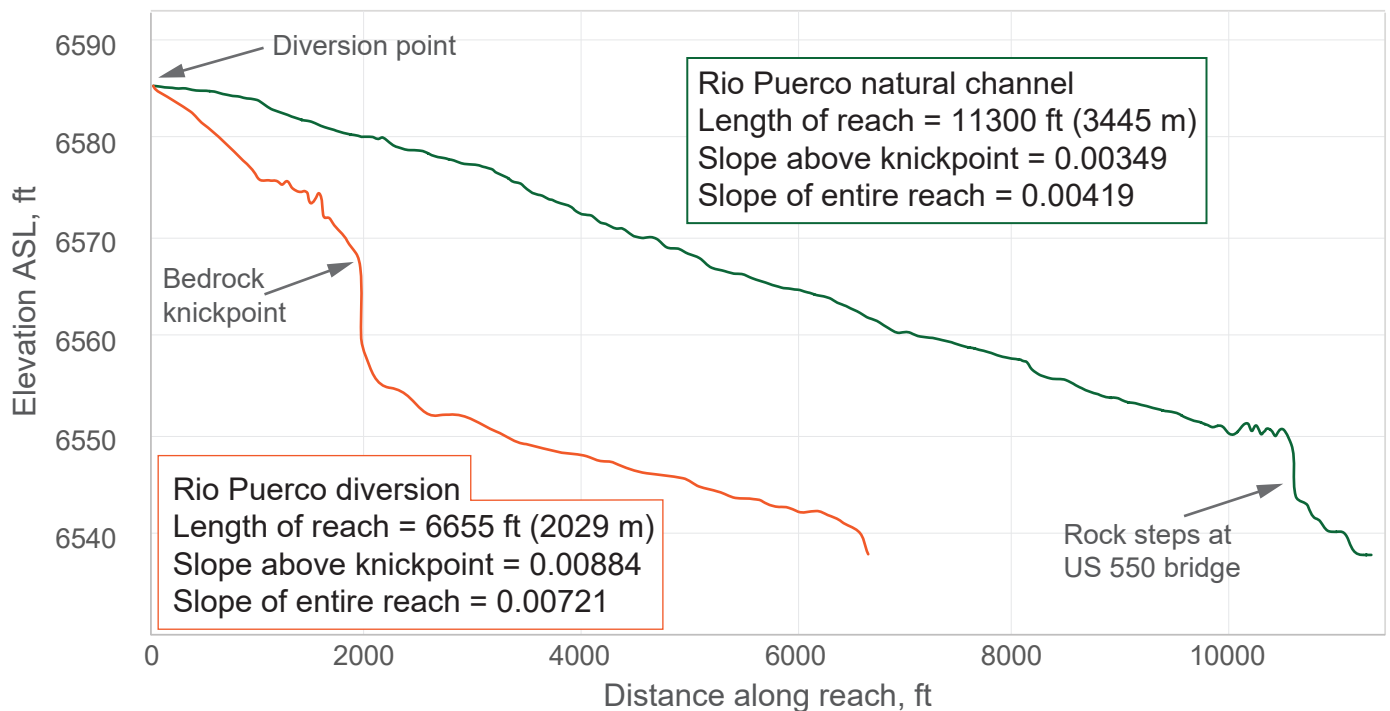
Figure 4. Stream profiles of the natural channel of the Rio Puerco (green) and the channelized reach (red) between the upper and lower diversion points.

Profiles of the thalwegs of the natural channel and channelized reach channel are shown in Figure 4. The slope of the natural channel between the upper and lower diversion points is 0.00419, close to the slope of 0.004 calculated from

topographic maps by Coleman et al. (1997). As seen in Figure 4, the engineered rock steps in the lowermost segment of this reach form a knickpoint. Below these steps, significant incision occurred between 1965 and 2006. The prediversion slope of this reach of Rio Puerco likely was closer to the 0.00349 value that exists above the rock steps (Fig. 4). The channel's slopes above and below these steps are in disequilibrium.

The slope of the thalweg of the channelized reach between the upper and lower diversion points is 0.00721, again close to Coleman et al.'s (1997) estimate of 0.0074. The bedrock knickpoint in the channelized reach is apparent in Figure 4; the channel's slopes above and below this knickpoint are in disequilibrium.

The upstream portion of the channelized reach was graded to a bedrock knickpoint (Fig. 4) that Coleman et al. (1997) reported was migrating upstream at a rate of 1 m/yr. At the same time, the upstream portion also had developed a short meander that had widened the channel to a width of 55 m. Given enough time, it is likely that the bedrock knickpoint would have migrated through the channelized reach entirely and into the natural channel above the diversion until the system found new

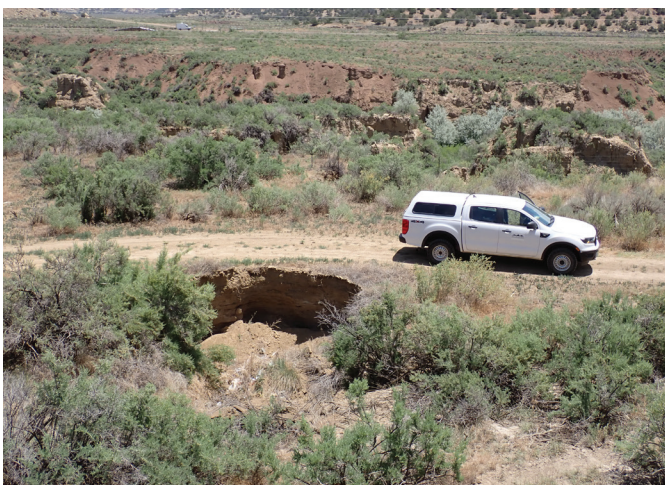
Figure 6. Photograph of soil collapse sinkhole in pre-20th century alluvium of the Rio Puerco along the channelized reach. Sinkhole is 7 m wide and at least 4 m deep.

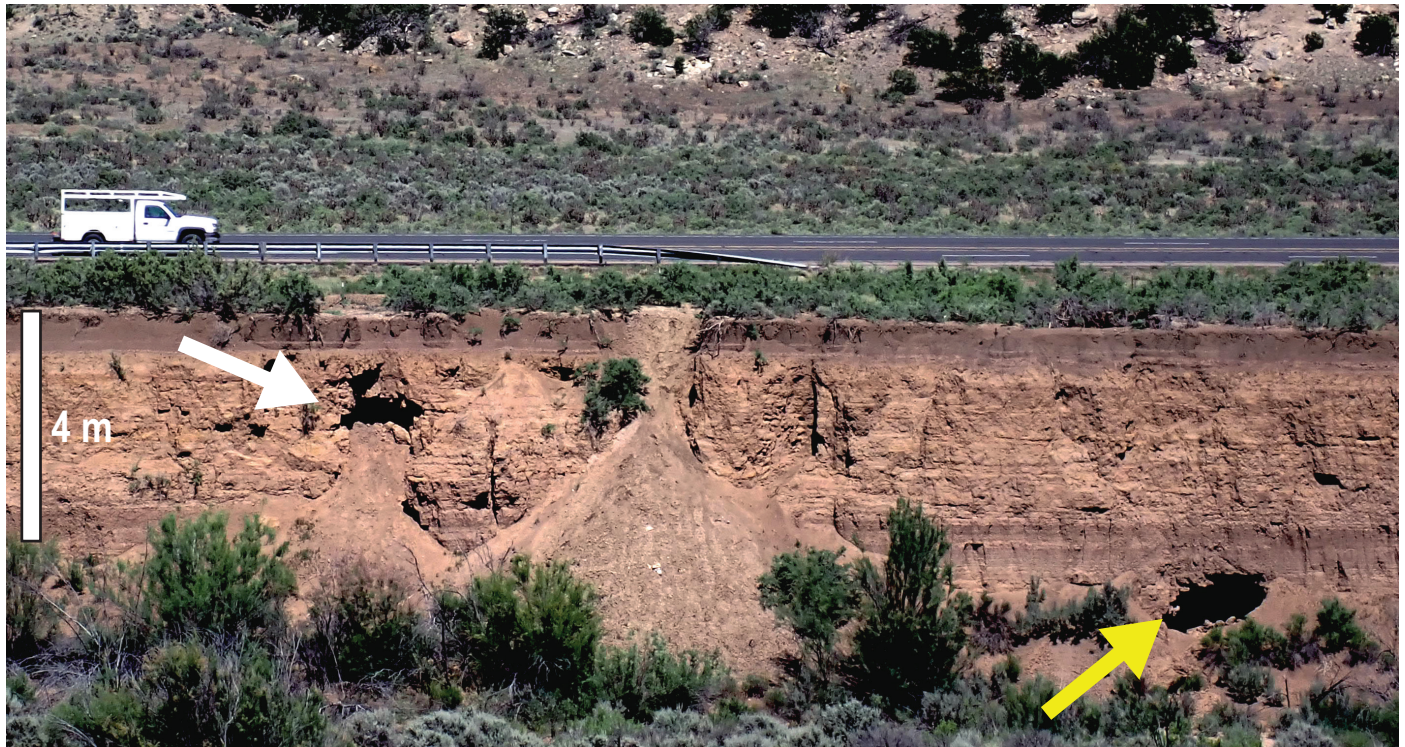
Figure 8. Photograph of the east bank of the Rio Puerco near the channelized reach showing soil pipes debouching into the Rio Puerco. White arrow marks 2 m-diameter soil pipe with an apron of sediment at its mouth indicating sediment delivery through soil pipes. Yellow arrow marks 3 m-diameter soil pipe. The large sediment apron in the center is at the base of a blind gully developed between the Rio Puerco and U.S. Route 550 and later breached by the eastward migration of the Rio Puerco arroyo wall. Photograph taken towards the east-northeast at approximately 4:30 P.M. on June 21, 2024, from approximately  $35.8476^\circ$ ,  $-106.9703^\circ$ .

Where soil pipes intersect with vertical or steep arroyo walls, there is evidence for sediment transport into the Rio Puerco and the formerly channelized reach in the form of sediment fans or aprons (Fig. 8). The volume of sediment delivered via soil pipes is not quantified but warrants further study.
