SUMMARY OF ENVIRONMENTAL ISSUES AT EL MOLINO MILL, NORTH-CENTRAL NEW MEXICO

PEGGY S. JOHNSON and JUDITH L. DEEDS

Abstract—The El Molino mill, located northwest of the Village of Pecos, New Mexico, has been investigated as a potential hazardous waste site under the Comprehensive Environmental Response, Compensation and Liability Act, or CERCLA, since 1985. Under the CERCLA process, the New Mexico Environment Department has identified the mill site as an operable unit requiring a remedial investigation, a feasibility study, remedial design/remedial action, and long-term operation and maintenance of a remediation plan. Three tailing impoundments constructed adjacent to El Molino mill in Alamitos Canyon are in close proximity to schools and residential areas in Pecos and pose potential risks to human health from contaminated soil and ground water. The tailing materials, characterized by low pH values and elevated concentrations of metals, may potentially affect nearby soils, surface water, air quality, and ground-water quality in domestic and municipal water supplies.

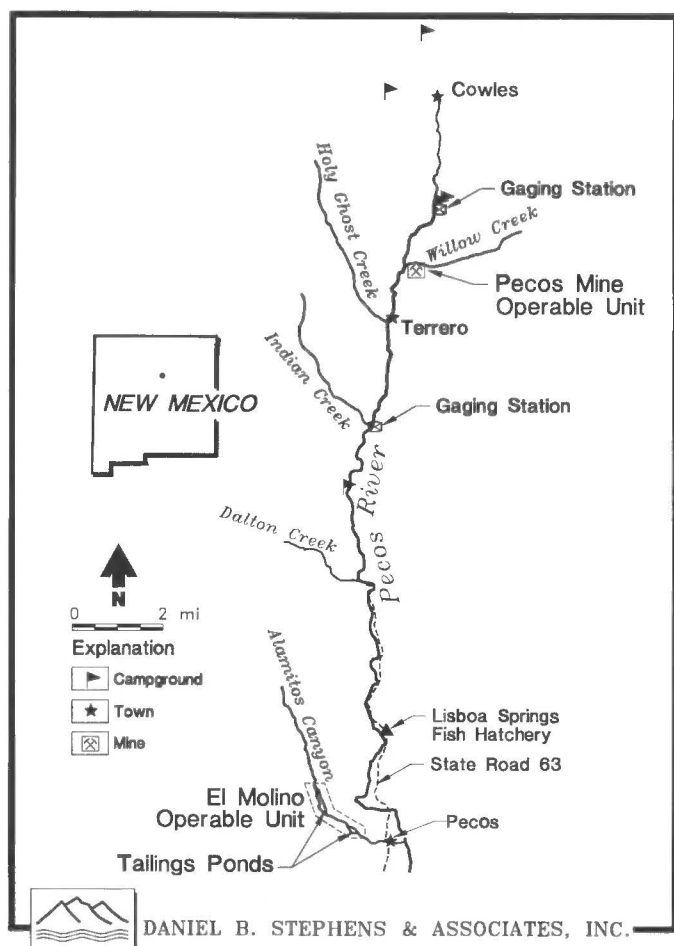
FIGURE 1. Location of Pecos mine and El Molino mill operable units.

The El Molino mill operable unit (Fig. 1), located in Alamitos Canyon within the Bert Clancy Fish and Wildlife Area, totals approximately 47 acres. Associated with the mill are three tailing impoundments constructed along an intermittent stream in Alamitos Canyon (Fig. 2). The upper two tailing impoundments (TP-1 and TP-2) were deactivated in 1939 and have been slowly eroding since that time. The largest and uppermost tailing impoundment, TP-1, is 33 acres in area. The middle tailing im-

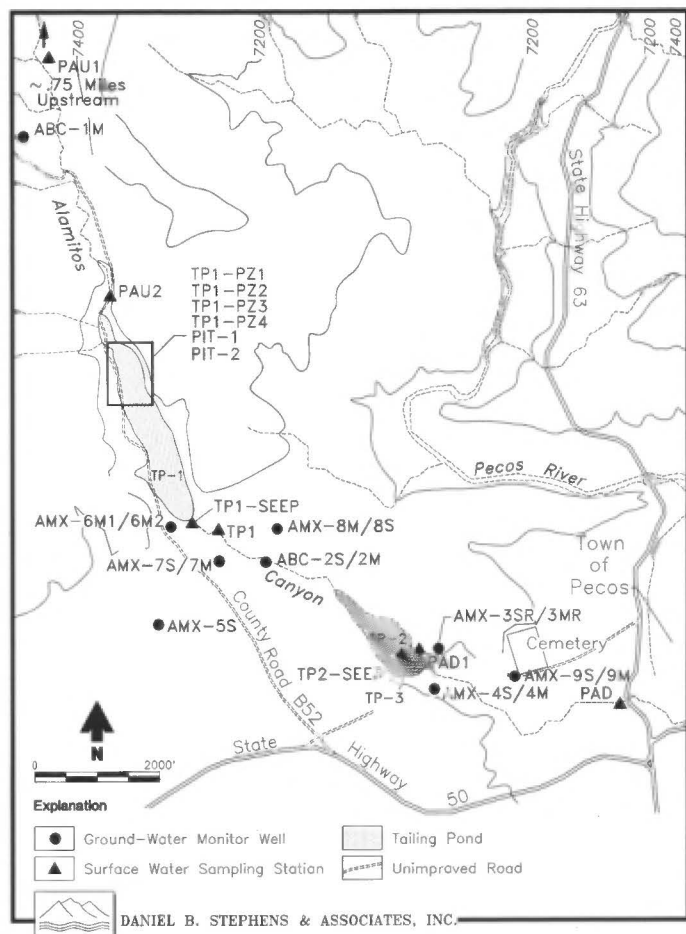
FIGURE 2. Water quality monitoring stations for El Molino mill.

A network of wells has been installed in Alamitos Canyon to monitor ground-water quality in, adjacent to, and downgradient of the tailing impoundments and to characterize hydrologic conditions in the area. There are currently 16 ground-water monitoring wells completed in the Madera Formation, 7 monitoring wells in the Sangre de Cristo, 7 monitoring wells in alluvial material adjacent to the tailing impoundments, and numerous piezometers in the tailing materials at each impoundment.
