The Broad Canyon Dam

William J. Fox

Las Cruces Country, Seager, W. R.; Clemons, R. E.; Callender, J. F.; [eds.], New Mexico Geological Society 26th Annual Fall Field Conference Guidebook, 376 p. <https://doi.org/10.56577/FFC-26>

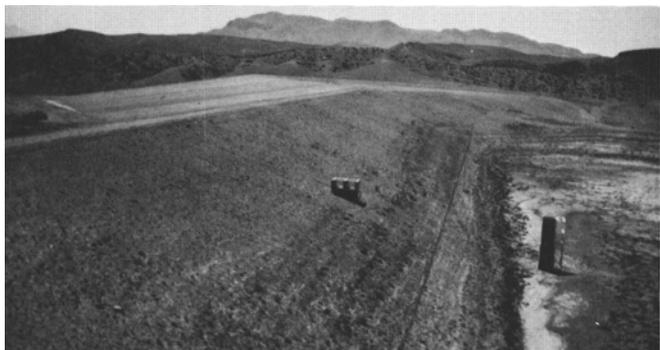
Photo by Soil Conservation Service
 Figure 1. The Broad Canyon Dam

398 ft maximum width at its base. The embankment consists of 781,700 cubic yards of compacted earthfill (Fig. 1). The reservoir has an as-built storage capacity of 6,080 acre-feet. Sediment storage for a design life of 100 years will utilize 2,278 acre-feet of that capacity. The emergency spillway is 520 ft wide and is protected by an 8-inch thick soil cement apron. The spillway has a design capacity to pass the runoff from a 4.5 inch rainfall at 6,630 cu ft/sec. The principal spillway consists of a 4 x 4 ft reinforced concrete box culvert and a 46-ft high, 12 x 4 ft inside diameter inlet with trash rack. A sediment pool drain carries the first stage of the drawdown flow. The principal spillway is designed to carry 580 cu ft/sec and will drain the runoff from a 2 percent chance of occurrence storm (6 hour, 3-inch rainfall) in 87 hours. These features can be seen in Figure 1. The pool drain appears to the right at the front toe of the dam. The top of the principal spillway inlet is seen in mid-embankment, and the smooth flat surface of the emergency spillway contrasts against the rounded low hills of the right abutment in the middle background.
