1985, pp. 325-329. <https://doi.org/10.56577/FFC-36.325>

FRACTURE-CONTROLLED GROUND-WATER DISTRIBUTION ADJACENT TO LOS ESTEROS RESERVOIR, GUADALUPE COUNTY, NEW MEXICO

JAY LAZARUS

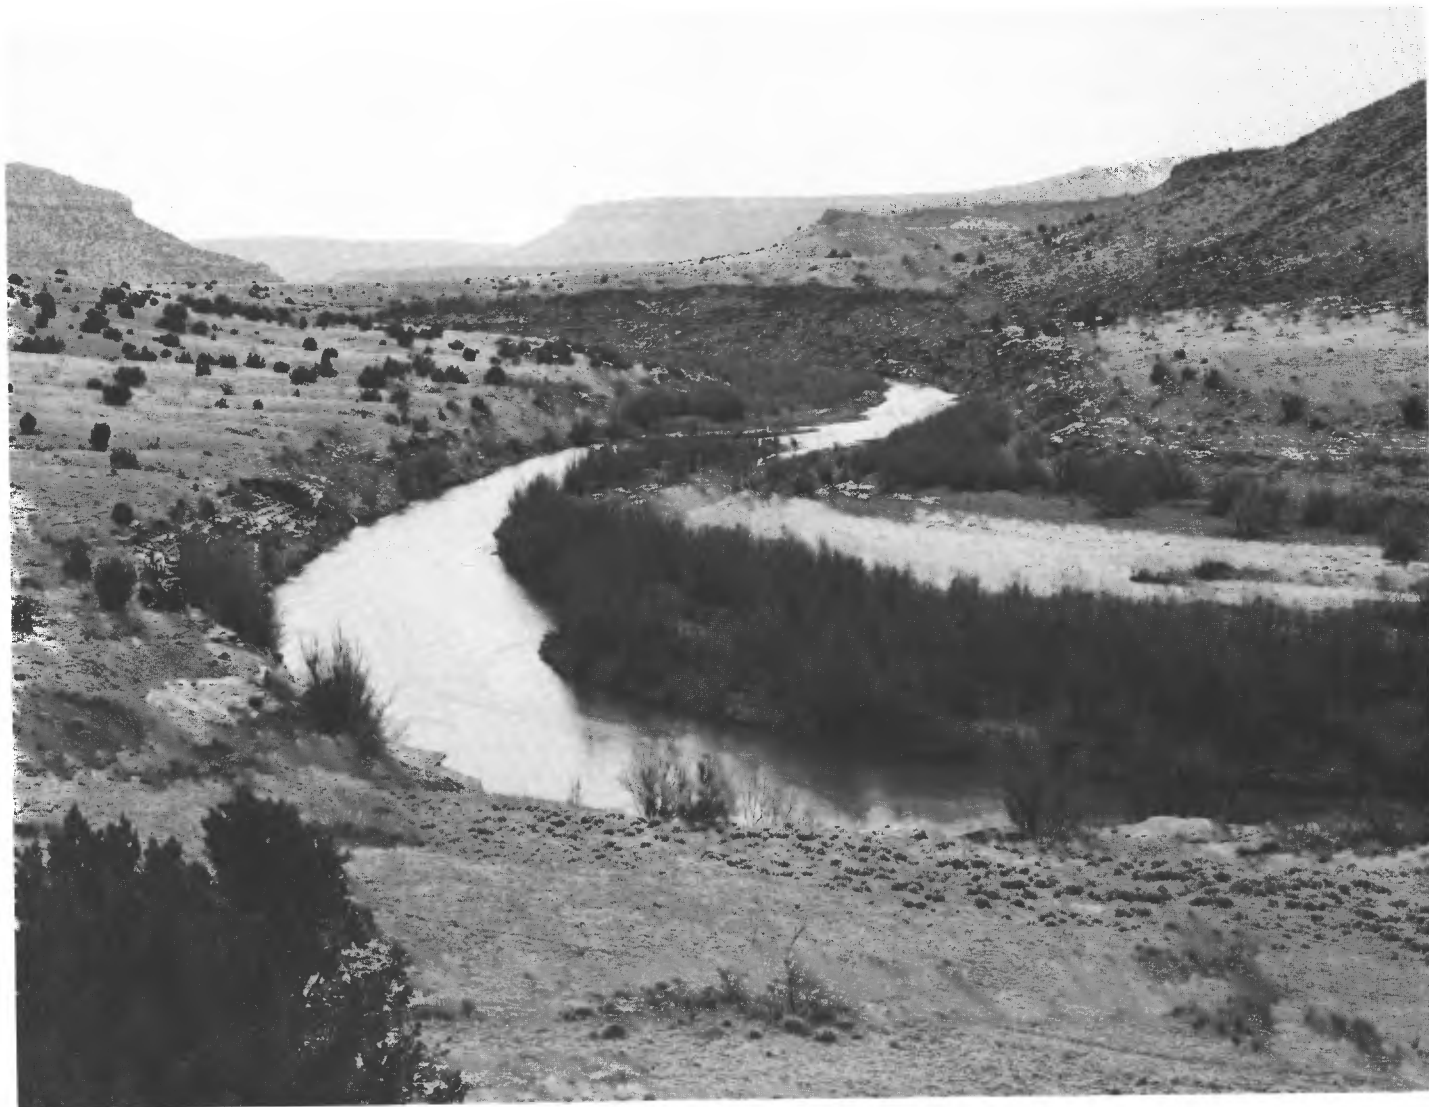
Canadian River and mouth of Canadian River Canyon near Sabinoso, New Mexico. View is N19°W upstream. Here the river leaves the canyon it has cut into the Las Vegas Plateau and flows south and east across lowlands toward Tucumcari. Triassic sandstones are exposed in banks of river. Slopes at right lead up to basalt-capped mesa. High mesas in distance and at left are underlain by Jurassic and Cretaceous rocks. Village of Sabinoso is behind promontory on left. Camera station is in sec. 34, T17N, R24E approximately 1/2 mi upstream from NM-65 bridge. W. Lambert photograph No. 85L28. 8 April 1985, 10:00 a.m., MST.
