Jay Lazarus, 1985, pp. 325-329

*Santa Rosa, Tucumcari Region*, Lucas, S. G.; Zidek, J.; [eds.], New Mexico Geological Society 36<sup>th</sup> Annual Fall Field Conference Guidebook, 344 p.

# FRACTURE-CONTROLLED GROUND-WATER DISTRIBUTION ADJACENT TO LOS ESTEROS RESERVOIR, GUADALUPE COUNTY, NEW MEXICO

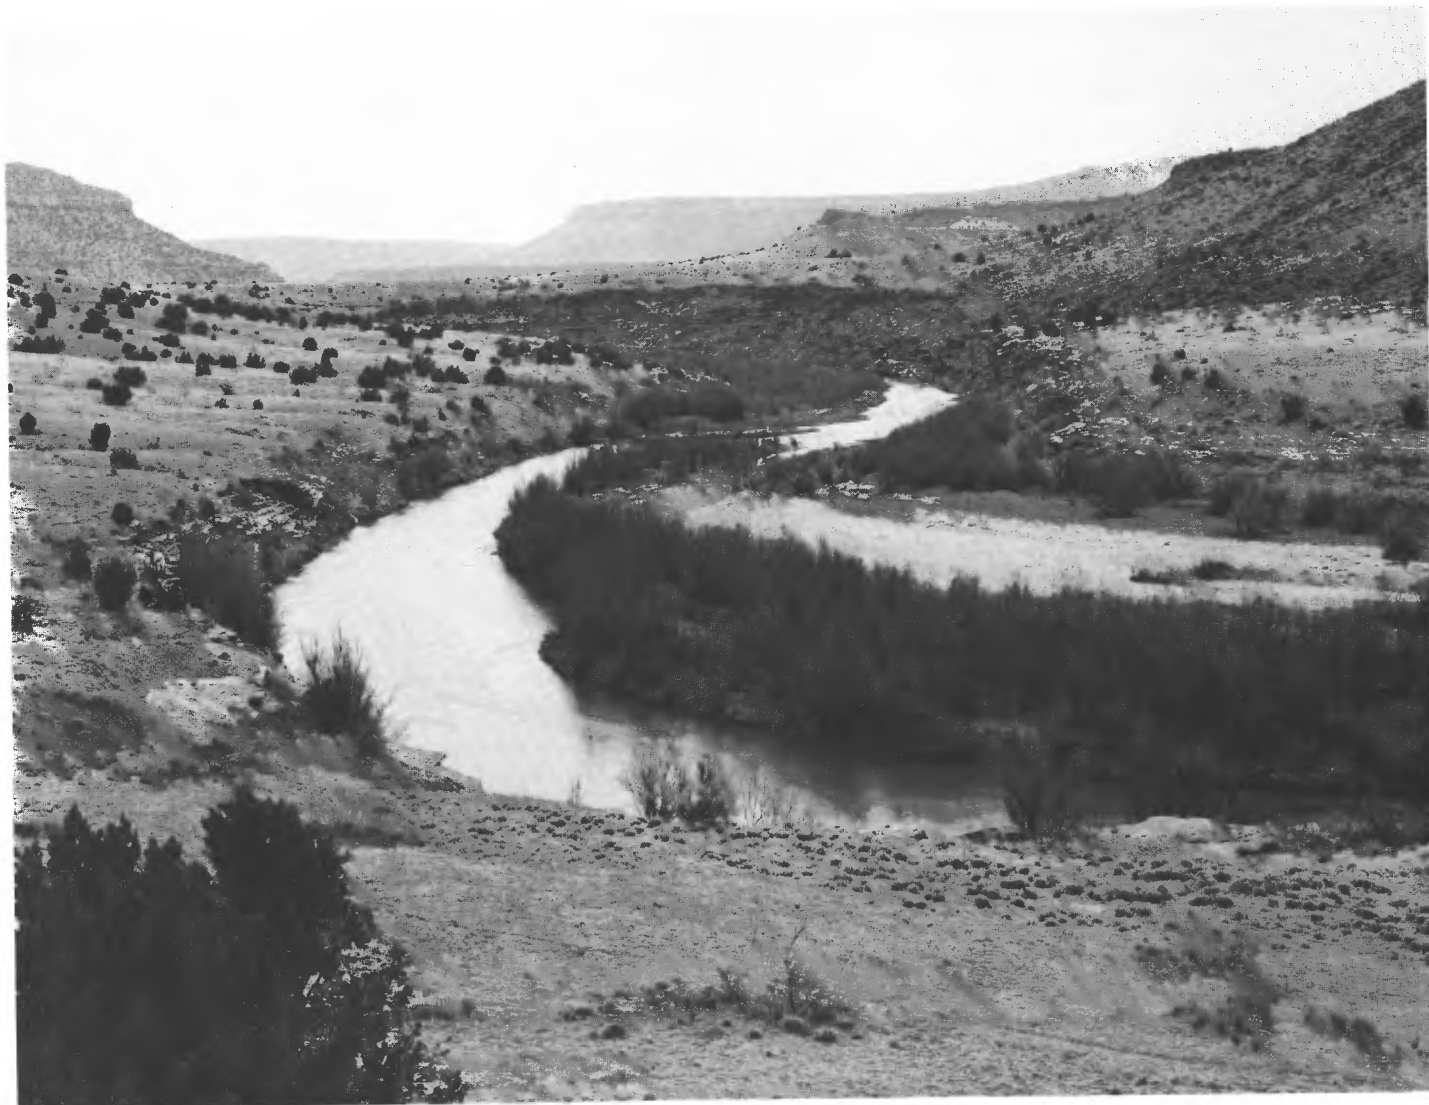
Canadian River and mouth of Canadian River Canyon near Sabinoso, New Mexico. View is N19°W upstream. Here the river leaves the canyon it has cut into the Las Vegas Plateau and flows south and east across lowlands toward Tucumcari. Triassic sandstones are exposed in banks of river. Slopes at right lead up to basalt-capped mesa. High mesas in distance and at left are underlain by Jurassic and Cretaceous rocks. Village of Sabinoso is behind promontory on left. Camera station is in sec. 34, T17N, R24E approximately 1/2 mi upstream from NM-65 bridge. W. Lambert photograph No. 85L28. 8 April 1985, 10:00 a.m., MST.
