Hydrogeology of the Ortiz Mountains and vicinity

John W. Shomaker, 1995, pp. 313-318

Geology of the Santa Fe Region, Bauer, P. W.; Kues, B. S.; Dunbar, N. W.; Karlstrom, K. E.; Harrison, B.; [eds.], New Mexico Geological Society 46th Annual Fall Field Conference Guidebook, 338 p.

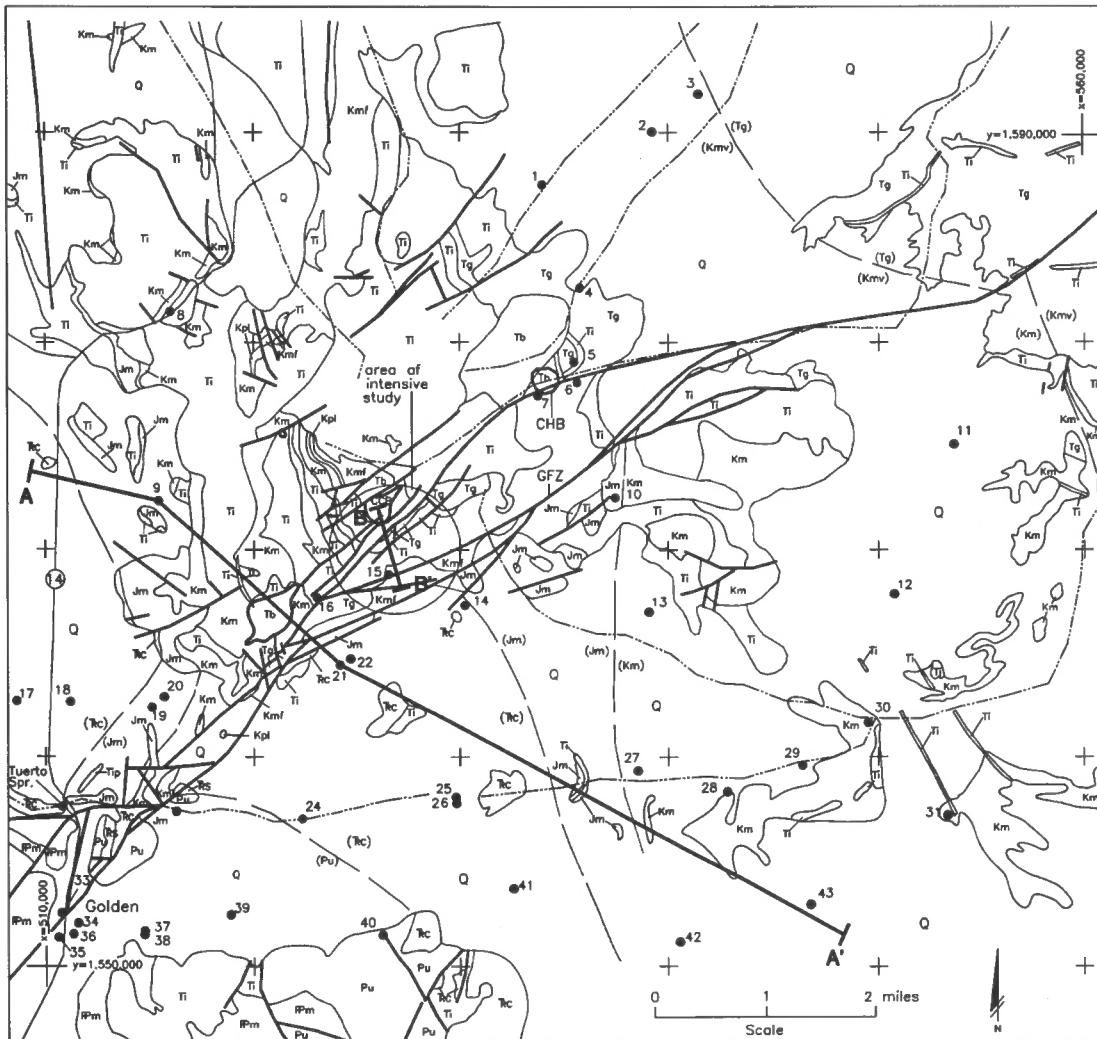
FIGURE 1. Geologic map of Ortiz Mountains and surrounding area, after Bachman (1975) and unpublished mapping by Pegasus Gold Corp. geologists. Heavy lines are faults; GFZ, Golden fault zone. Long-dashed lines are inferred subcrops beneath alluvium. Stratigraphic units: Q, Quaternary-age alluvium, colluvium, and fluvial sediments; Tb, Tertiary breccia (CHB, ore body in Cunningham Hill breccia pipe; CCB, Carache Canyon breccia pipe); Ti, Tertiary intrusive rocks; Tg, Galisteo Formation; Km, Mesaverde Group (including Km, Menefee Formation; and Kpl, Point Lookout Sandstone); Kd, Mancos Shale; Ks, Dakota Sandstone; Jm, Morrison Formation; Je, Entrada Sandstone; Trc, Chinle Formation; Trs, Santa Rosa Sandstone; Pu, Permian rocks, undivided; Psag, San Andres Limestone and Glorieta Sandstone; Py, Yeso Formation; Pa, Abo Formation; Pm, Madera Formation.

The writer's studies, in 1988 through 1993 for Pegasus Gold Corp. and Lac Minerals (USA), Inc., have been related to water supply and dewatering of workings for proposed mining and beneficiation projects in the Carache Canyon area, and farther to the southwest (Fig. 1). These studies, partly in collaboration with James W. Mahar, are in SEO files under File Nos. RG-51887 and RG-50321.

The geologic units that constitute the system of aquifers and confining beds are shown on the geologic map and cross-section, Figures 1 and 2. Descriptions of these units may be found in many papers, particularly the studies by Stearns (1953), Disbrow and Stoll (1957), Kelley and Northrop (1975), Bachman (1975) and Maynard et al. (1990); the reports by Summers include a comprehensive summary of the stratigraphy. In this paper, emphasis will be on hydrogeologic properties of the units.

The Kelly Replacement well (no. 37, Fig. 1, Table 1) is completed in the Madera. Results of the aquifer test showed the influence of fracture-flow. A 68-hour constant-rate test at 450 gallons per minute (gpm) gave a specific capacity of about 8.4 gallons per minute per foot of drawdown (gpm/ft), and a transmissivity of about 2390 feet squared per day (ft^2/day) based on drawdown measurements after 300 minutes (Table 1). Analysis of recovery data gave a much higher apparent transmissivity, probably influenced by delayed recovery due to refilling of fractures near the water table. The hydraulic conductivity of the Madera is probably much less where the unit is at greater depth and unfractured.

There have been two tests of wells in the Morrison Formation, one, an injection test by Summers of well LM-1, and the other of well LC-GM-1 (nos. 28 and 20, Fig. 1). LM-1 is far from the Golden fault zone, and probably intersected no fractures; hydraulic conductivity for the 100-ft open interval was estimated at 0.001 ft/day.

Seven wells shown on Figure 1 tap the Mesaverde Group, which includes the Point Lookout Sandstone, Menefee Formation and Harmon Sandstone (Table 1). Well OR-3 (no. 5, Fig. 1, Table 1) and the New Las Norias well (no. 4) were tested by Summers. Transmissivity was 60 to $441 \text{ ft}^2/\text{day}$ for the former and 58 to $75 \text{ ft}^2/\text{day}$ for the latter, but both wells are in an area of complex structure and much fracturing, close to the Cunningham Hill breccia pipe, and hydraulic conductivity is probably greater than would be found in unfractured Mesaverde rocks.

Well OBS-64 (no. 7, Fig. 1, Table 1) was completed in the breccia pipe, but outside the limit of mining, and became a supply well for the operation. It is located in the fracture zone associated with the Golden fault zone. Summers tested the well. A step-drawdown test gave inconclusive results, in that the well continued to develop during pumping,
