## ***Third-day road log, from Living Desert State Park turnoff at US 285, north to Brantley Dam and Lake McMillan, through Artesia, Lake Arthur, Hagerman, Dexter and ending at Bottomless Lakes State Park***

Lewis Land and David Love

2006, pp. 85-96. <https://doi.org/10.56577/FFC-57.85>

*Caves and Karst of Southeastern New Mexico*, Land, Lewis; Lueth, Virgil W.; Raatz, William; Boston, Penny; Love, David L. [eds.], New Mexico Geological Society 57<sup>th</sup> Annual Fall Field Conference Guidebook, 344 p.

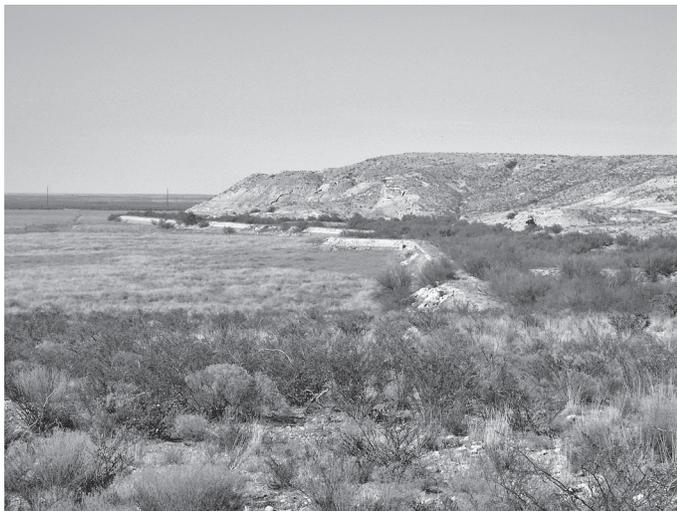
FIGURE 3.1. Dry lake bed of old Lake McMillan. McMillan Escarpment on horizon to right, formed in Seven Rivers evaporites and redbeds capped by dolomite on the ridge crest. The dike at the base of the escarpment was constructed in the early 20th century in an attempt to prevent loss of water into sinkholes along the eastern margin of the lake. Note gypsum fissures in face of escarpment.

- 15.9** **Stop 1: McMillan Dam and old Lake McMillan lake bed. Park on shoulder.**  
Breached dam straight ahead. Note man-made dike along east margin of lake, at base of McMillan Escarpment (Figure 3.1).

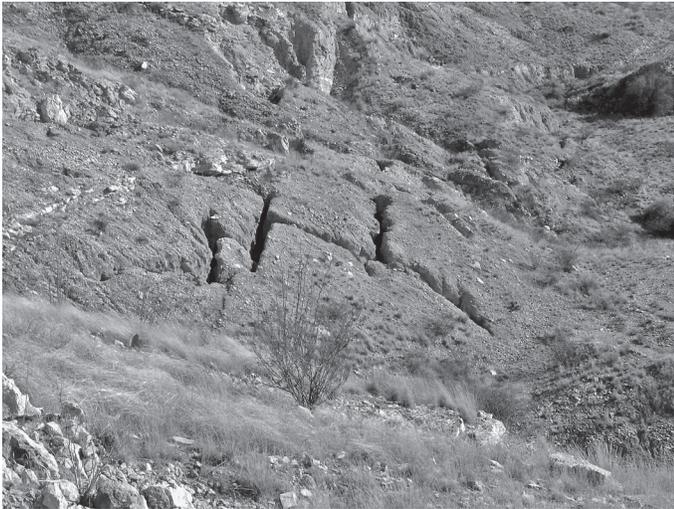
FIGURE 3.2. Continued mass-wasting processes indicated by large gypsum fissures formed in the face of the McMillan Escarpment.

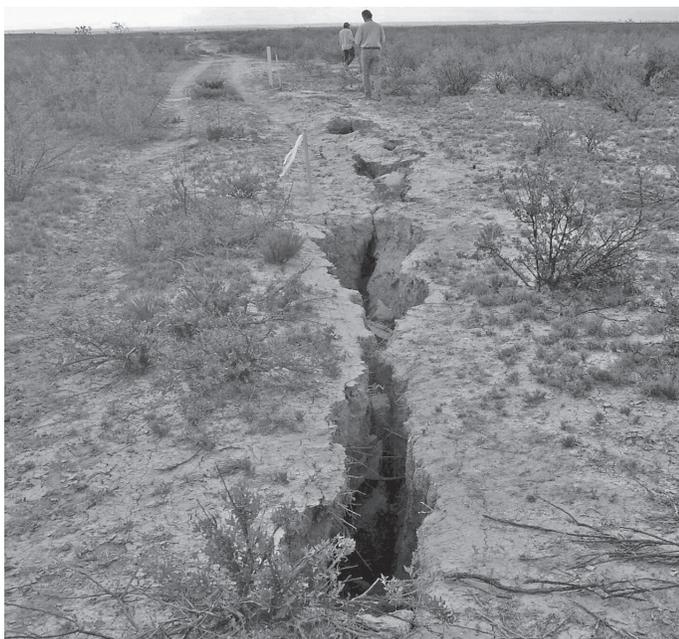
FIGURE 3.3. Fissure crossing pipeline access road south of Artesia, developed in alluvium overlying Seven Rivers evaporites.

**13.7** BP pipeline crosses under road. Three years ago several shallow fissures were discovered by a BP aerial survey in the vicinity of the pipeline (Figure 3.3). The fissures are probably associated with subsurface dissolution and subsidence in the Seven Rivers gypsum, which underlies the alluvial valley fill in this area. Depth of some of the fissures exceeds 1 m (Figure 3.4). 2.2

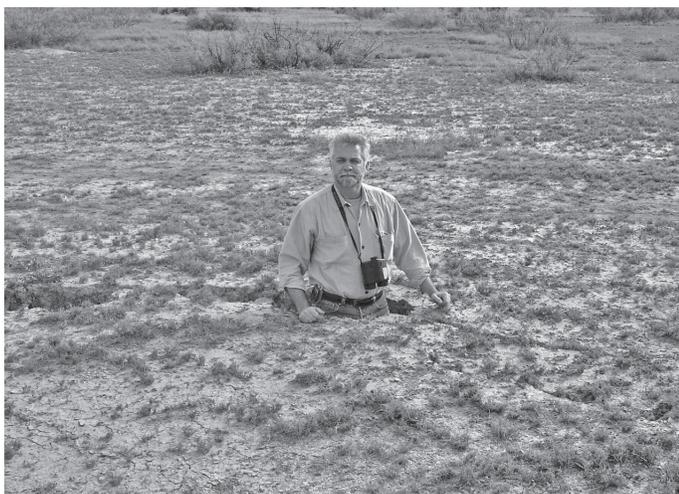
FIGURE 3.4. Close-up of earth fissure near pipeline south of Artesia. Consultant for scale (consultant is ~2 m in length).

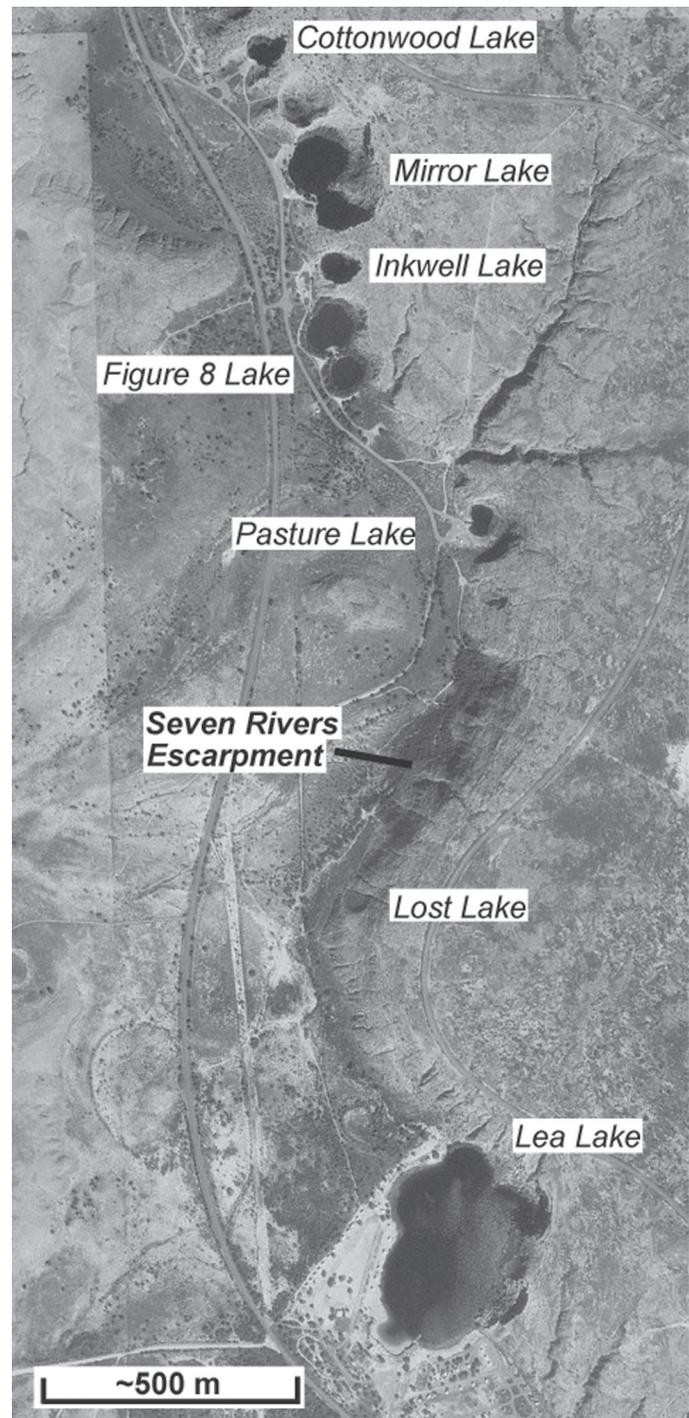
FIGURE 3.7. Digital orthophoto image of Bottomless Lakes State Park, showing flooded cenotes. Lazy Lagoon, the northernmost of the lakes, is off the map to the north. All the lakes visible in this image are formed in gypsum and redbeds within the Seven Rivers Escarpment, a geologic setting similar to that observed at Lake McMillan.

**59.8** Stop sign. Turn left toward Bottomless Lakes State Park (Figure 3.7). 0.2

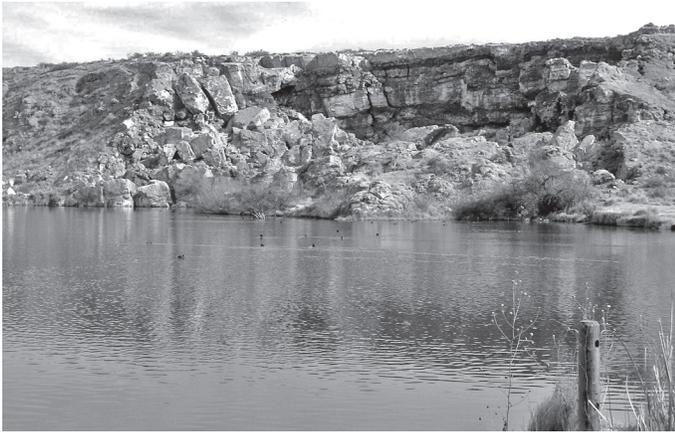
FIGURE 3.8. Rockslide in Seven Rivers Escarpment, eastern shore of Lea Lake cenote. Large gypsum boulders are present on the lakebed in ~8 m water depth at the base of the escarpment. At least half a dozen submerged springs discharge from the lakebed at this location.

Note that the sinkhole is formed in and at the base of the Seven Rivers Escarpment. Note also large rockslides on far side of lake (Figure 3.8). 0.2

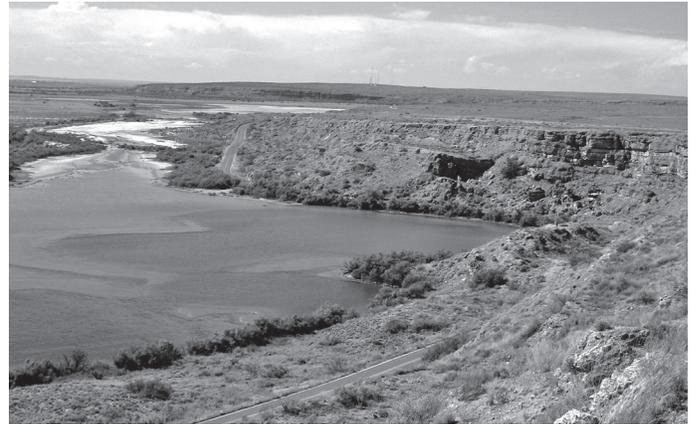
FIGURE 3.9. Lazy Lagoon, formed in an abandoned channel of the Pecos River, appears to be a single body of water when water levels are high. In fact the lake consists of three sinkholes with a maximum depth >25 m. Note large rotated slump blocks on Seven Rivers Escarpment near center of image. See Plate 16A for a color image of this feature.

63.7 Lazy Lagoon at base of escarpment to left, formed in an abandoned channel of the Pecos River (Figure 3.9). 0.3

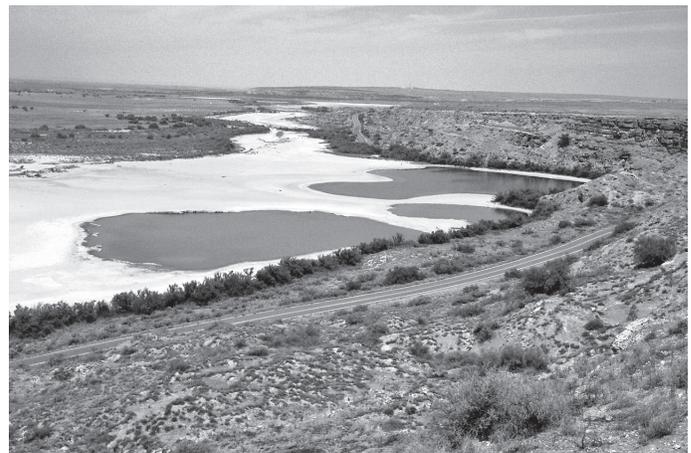
FIGURE 3.10. Overview of Lazy Lagoon during summer months, when water levels are low due to increased irrigation pumping from Artesian Aquifer. See Plate 16B for a color image of this feature.

appears to be a single body of water. It is in fact three sinkholes formed in an abandoned channel of the Pecos River, the southernmost of which is over 25 m deep (Figure 3.10). The Lazy Lagoon sinkholes contain the most saline water in the park, with TDS exceeding 37,000 ppm, greater than the salinity of seawater. View back to north shows excellent examples of mass wasting, with large gypsum slump blocks detached from escarpment.

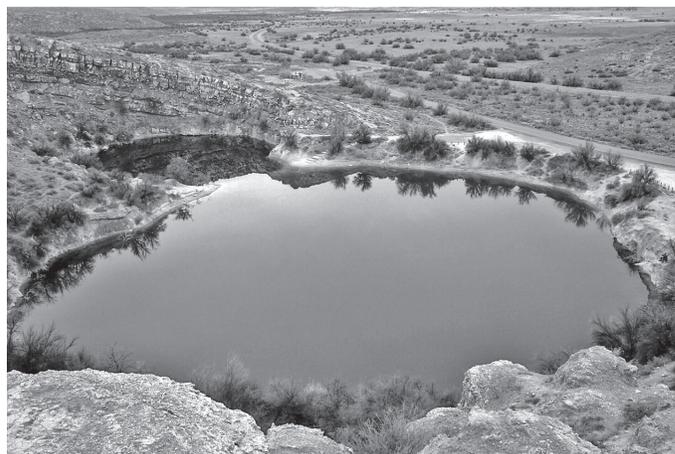
FIGURE 3.11. Overview of Mirror Lake, which consists of two cenotes that have grown together. Note the pronounced west dip well-exposed in the walls of the sink. Regional dip is  $\sim 1^\circ$  to the east. This local dip reversal is caused by subsurface dissolution of gypsum along the escarpment. See back cover for a color image of this feature.

the north margin of Mirror lake. Note the pronounced west dip exposed in the walls of the Mirror Lake cenote. Regional dip is about  $1^\circ$  to the east. This local dip reversal is probably caused by subsurface dissolution of gypsum along the escarpment.

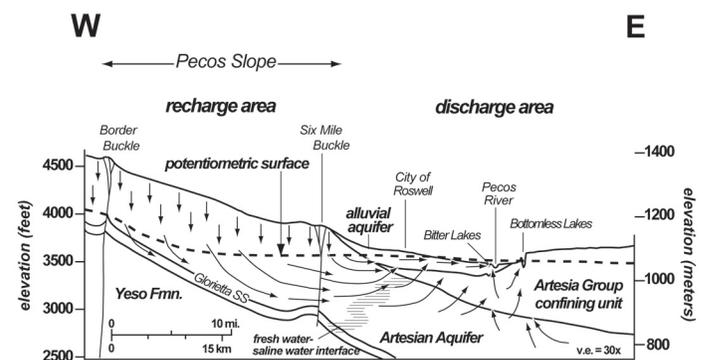
FIGURE 3.11. Schematic cross section of the artesian aquifer system in the vicinity of Bottomless Lakes State Park.

Bottomless Lakes Park is located on the eastern margin of the Roswell Artesian Basin. The basin is generally characterized as a two-aquifer system, consisting of an eastward-dipping carbonate aquifer overlain by a leaky confining unit, which is in turn overlain by an unconfined alluvial aquifer (Figure 3.11). The carbonate aquifer is artesian to the east but under water table conditions in the western outcrop area, on the Pecos Slope. Within the carbonate aquifer, groundwater is stored in highly porous and transmissive zones of secondary porosity represented by vuggy to cavernous limestones, intraformational solution collapse breccias, and solution enlarged fractures, developed primarily in the San Andres limestone and to a lesser extent in the overlying Grayburg and Queen Formations. Much of the secondary porosity formed by subsurface dissolution of evaporites within the San Andres Formation during late Permian time. Slightly to moderately permeable rocks of the Artesia Group, including the Seven Rivers Formation, serve as the upper confining unit for the artesian aquifer. Thickness of the confining unit varies from 0 to ~300 m, thickening downdip to the east. Confining beds are truncated by erosion to the west (Welder, 1983).

man, 1964; Kelley, 1971). Groundwater flows east and south, down gradient from the recharge area, then upward through leaky confining beds into the alluvial aquifer, and ultimately into the Pecos River (Figure 3.11). Estimates of the time required for groundwater to move from the recharge area to discharge sites in the Artesian Basin vary widely, with some estimates as low as 4 to 7 years, equating to a particle flow velocity of 20 m/day (Rabinowitz et al., 1977). This is a remarkably rapid flow rate for groundwater, even in a karstic aquifer. Recent measurements of environmental tracers in springs and sinkhole lakes at Bitter Lakes National Wildlife Refuge suggest a groundwater residence time of 20 to 50 years (Land, 2005).
