The Broad Canyon Dam

THE BROAD CANYON DAM

WILLIAM J. FOX

Soil Conservation Service, Albuquerque, New Mexico 87103

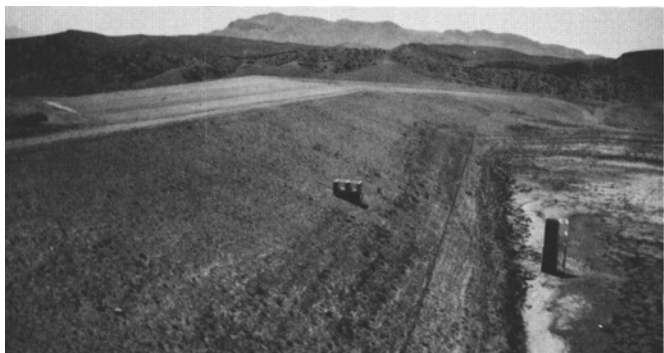
Photo by Soil Conservation Service
 Figure 1. The Broad Canyon Dam

398 ft maximum width at its base. The embankment consists of 781,700 cubic yards of compacted earthfill (Fig. 1). The reservoir has an as-built storage capacity of 6,080 acre-feet. Sediment storage for a design life of 100 years will utilize 2,278 acre-feet of that capacity. The emergency spillway is 520 ft wide and is protected by an 8-inch thick soil cement apron. The spillway has a design capacity to pass the runoff from a 4.5 inch rainfall at 6,630 cu ft/sec. The principal spillway consists of a 4 x 4 ft reinforced concrete box culvert and a 46-ft high, 12 x 4 ft inside diameter inlet with trash rack. A sediment pool drain carries the first stage of the drawdown flow. The principal spillway is designed to carry 580 cu ft/sec and will drain the runoff from a 2 percent chance of occurrence storm (6 hour, 3-inch rainfall) in 87 hours. These features can be seen in Figure 1. The pool drain appears to the right at the front toe of the dam. The top of the principal spillway inlet is seen in mid-embankment, and the smooth flat surface of the emergency spillway contrasts against the rounded low hills of the right abutment in the middle background.
